## **D1.1 Mission report Bhadra dam and reservoir Karnataka, India**

**Deltares in cooperation with iPresas, SkyGeo and Royal  
Eijkelpamp**

11200775-001

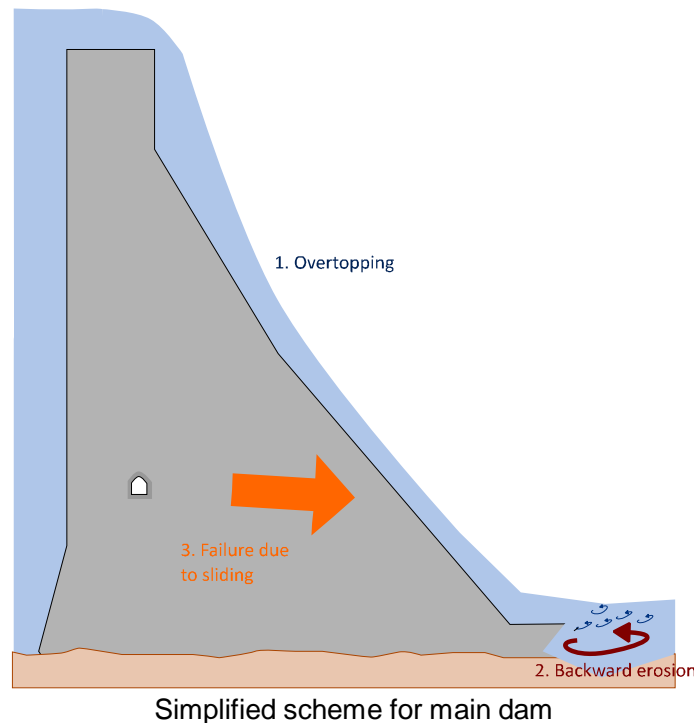
**FM1. Overtopping [main dam]**

In a hydrologic scenario, due to a severe flood and/or inadequate spillway capacity and/or inability to open the gates of the spillways, adequate freeboard cannot be maintained and this can result in overtopping of the dam crest level. Flow over the crest washes out material in the dam toe and causes massive erosion that progresses leading to dam failure.

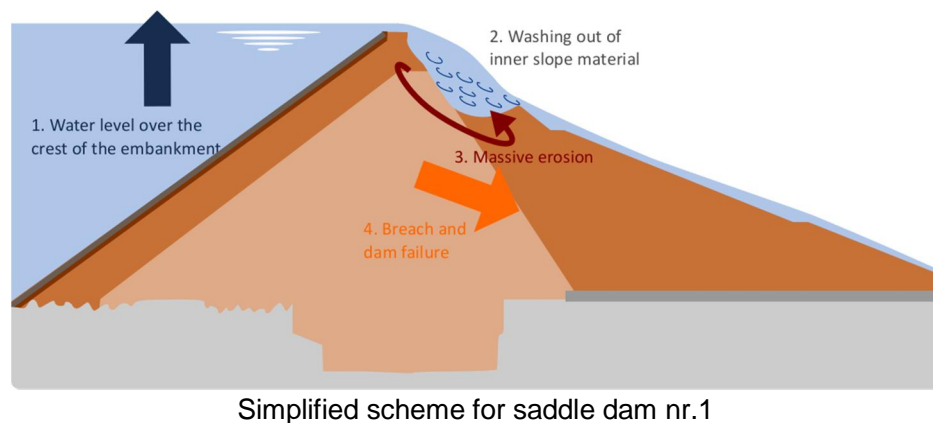
**FM2. Overtopping [saddle dams]**

In a hydrologic scenario, due to a severe flood, the spillway at the main dam has insufficient hydraulic capacity to pass the flood event and maintain adequate freeboard and water level raises over saddle dams. Flow over the crest washes out material in the downstream slope of the embankment and causes massive erosion that progresses leading to slope instability, breach and dam failure.

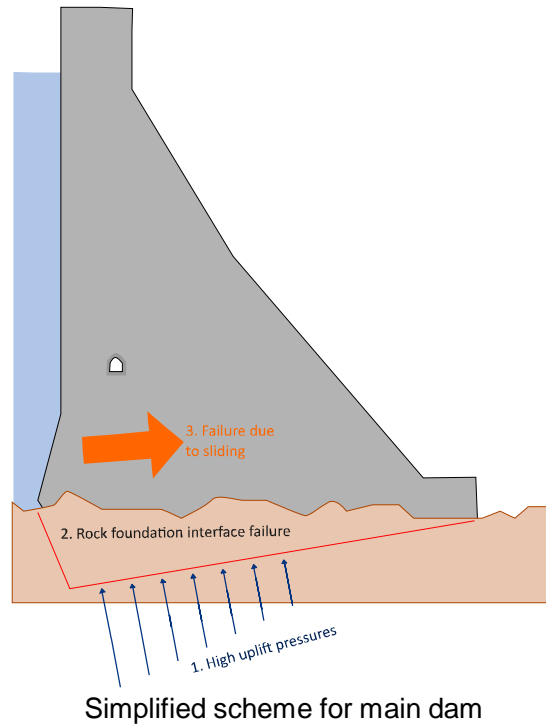
## FM3. Sliding [main dam] (interface at rock foundation)

In a normal or extreme hydrologic scenario, the combination of hydrostatic loads and uplift pressures produces a movement or deformation in dam foundation over a surface, resulting in loss of foundation strength.

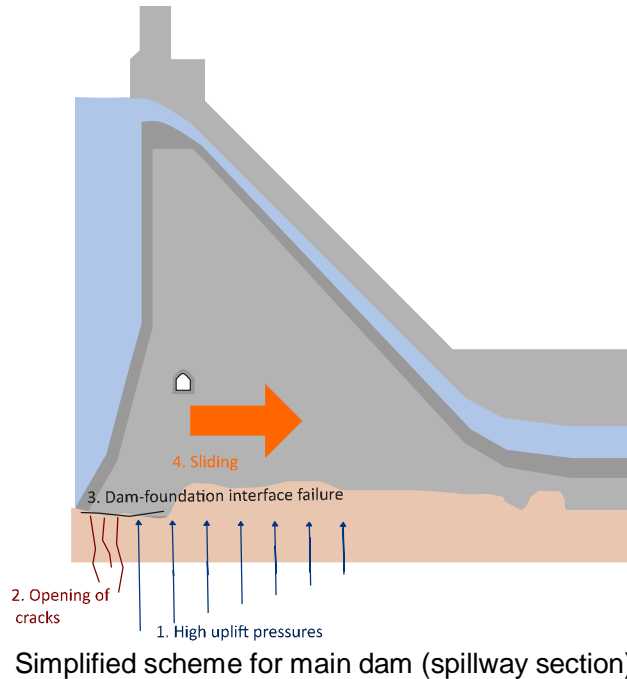
## FM4. Sliding [main dam] (interface at dam-foundation contact).

In a normal or extreme hydrologic scenario, there is an increase on hydraulic loads and uplift pressures (1) that produces a tensile crack (2) at the foot of the dam-foundation interface, and produces an increment in the hydraulic gradient at foundation joint close to the dam-foundation interface, this results in erosion in the foundation material (3) resulting in sliding of part of the dam body along a failure surface (4).

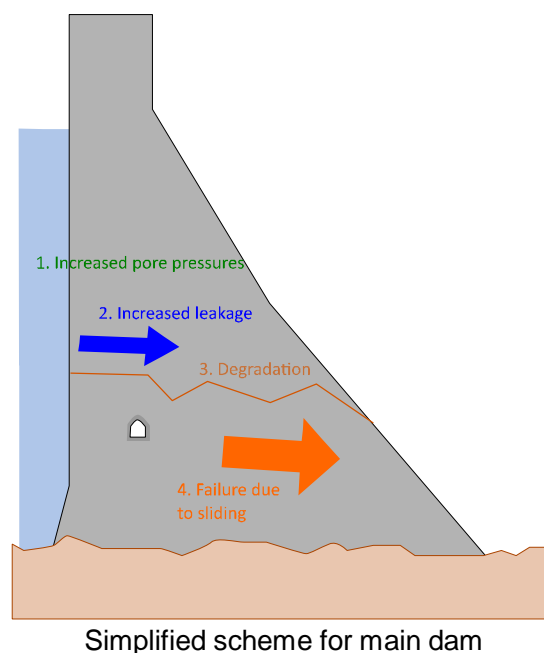
## FM5. Sliding [main dam] (degradation of masonry material)

In normal or extreme hydrologic scenario, pore-water pressures increase along with an increase of leakage through dam body, resulting in deterioration of masonry to an extent that affects stability and leads to dam failure.

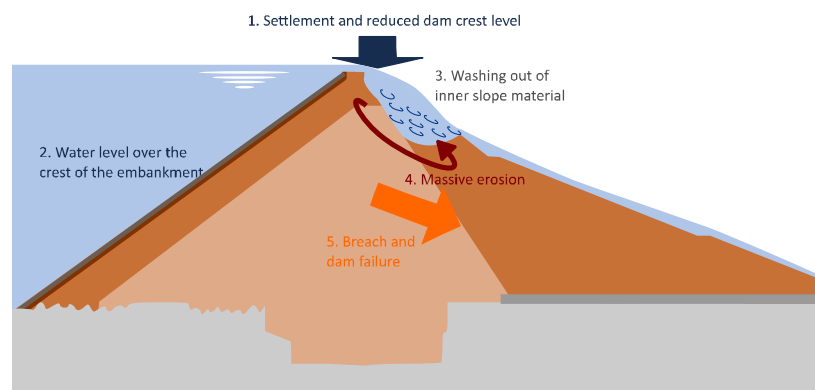
## FM7. Overtopping failure in a seismic event [saddle dams].

In a seismic scenario, the earthquake causes a ground motion with shaking and cause settlement of embankment dams with reduced dam crest level, then resulting in uncontrolled flow over the dam crest, degradation of inner slope material, massive erosion and dam collapse.

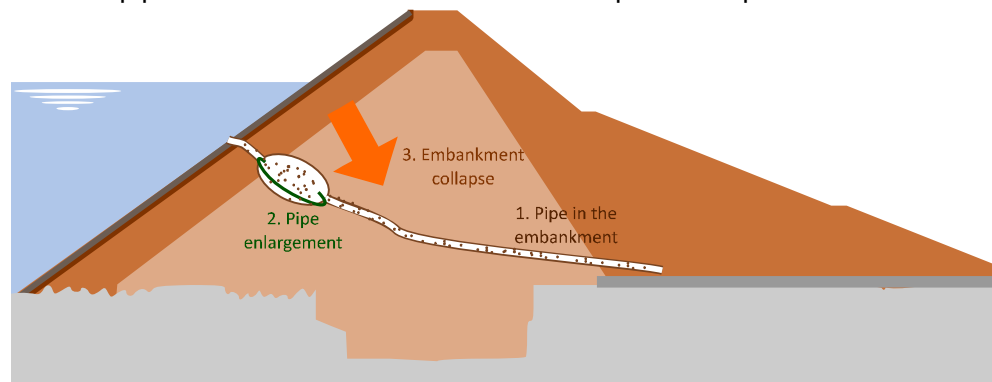
## FM8. Failure due to internal erosion [saddle dams].

In normal scenario during a period of high reservoir elevation, an increase in permeability and/or reduction in strength of the core occurs over time, then piping of the embankment core initiates at the foundation interface. Backward erosion occurs until a “pipe” (seepage path) forms through the core, not detected or ignored, reaching the upstream face below the reservoir level. Rapid erosion and enlargement of the pipe occurs and embankment dam collapse takes place.

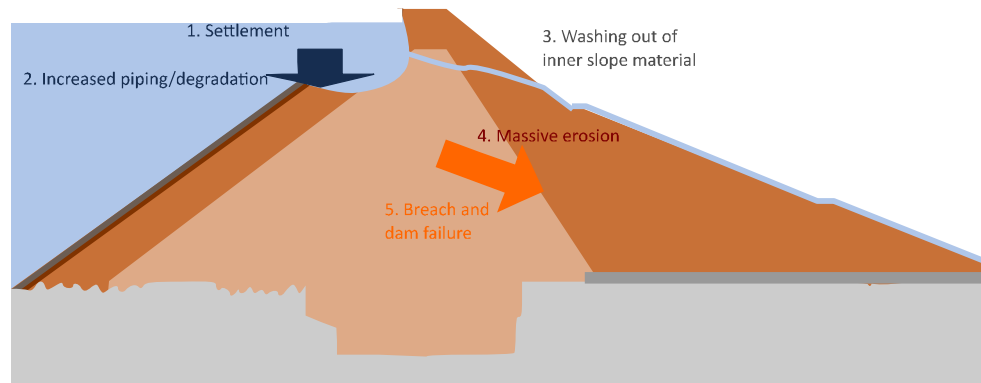
**FM9. Failure due to settlement [saddle dams]***Short description:*

During a period of high reservoir elevation, one or more slips occur within the embankment because design loads are exceeded or through deterioration of embankment-fill materials over time, resulting in settlement of the outside slope (upstream face) and increased degradation of core material and piping, resulting in degradation of inner slope and dam collapse.
