## Dam risk analysis for Bhadra dam and reservoir system

July 2018

**DAM RISK ANALYSIS FOR BHADRA DAM AND RESERVOIR  
SYSTEM  
D2.1**

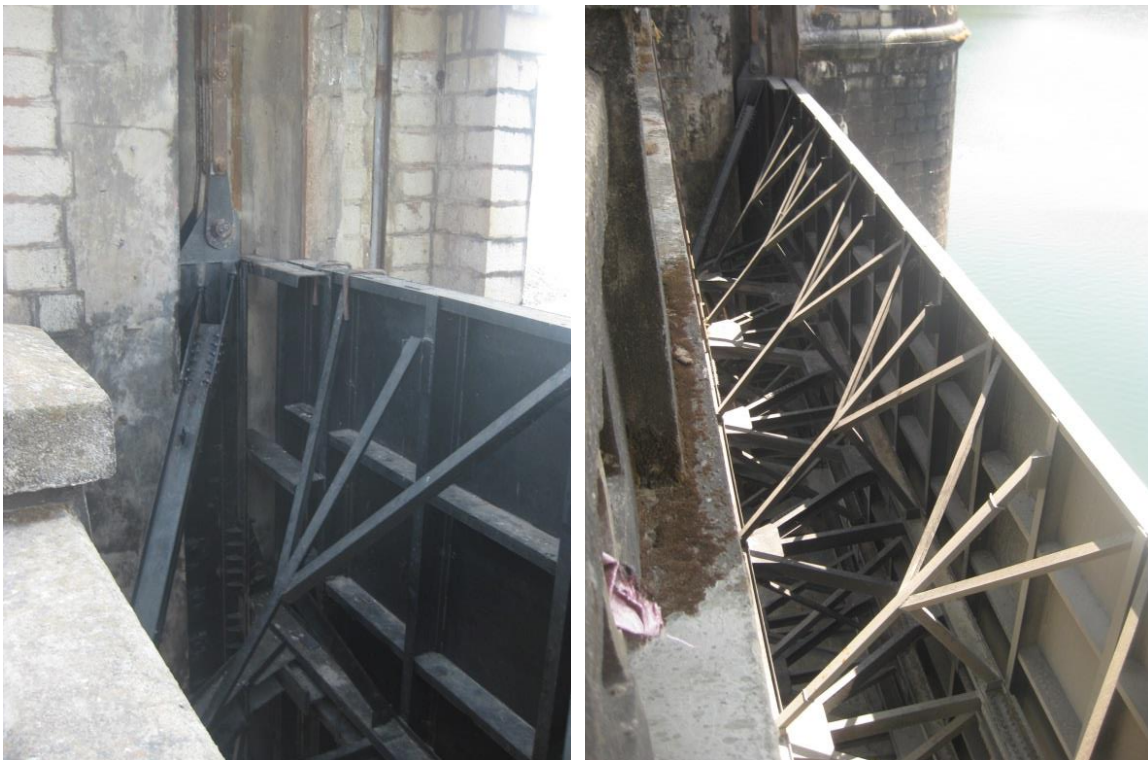
As stated in TN2017, in the period 1999-2000 it was stated that for the rollers for all 4 of the crest gates were damaged and needed immediate replacement. All gate rollers assemblies were refixed and realigned with new cast steel rollers.

Figure 4.5. View of spillway gates during site visit on 21 February 2017.

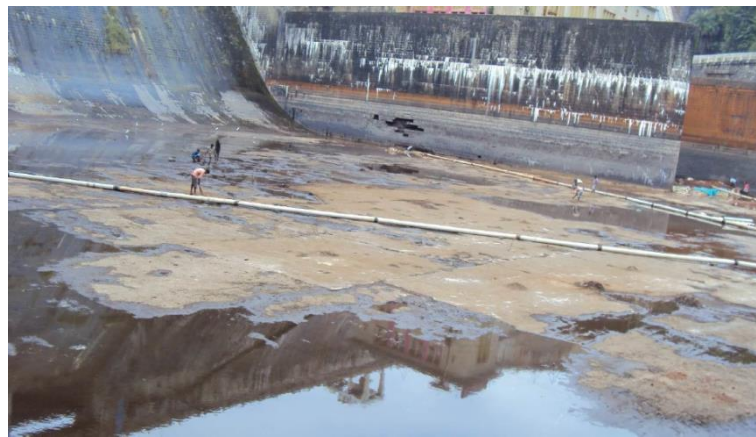
Repair works in the stilling basin were conducted under the DRIP project in 2017. Some pictures of the process are included here. Demolition of the old eroded stilling basin concrete was conducted and stilling basin repairs included drilling of holes for fixing rock anchors at the stilling basin, reinforcement of concrete in the stilling basin area and repair of the wall between the stilling basin and scour sluice channel. In addition, removal of loose debris from the tail channel was performed. Some pictures of these repairs are shown below.

Figure 4.6. View of the stilling basin after dewatering and cleaning. Source: CSV20170921.

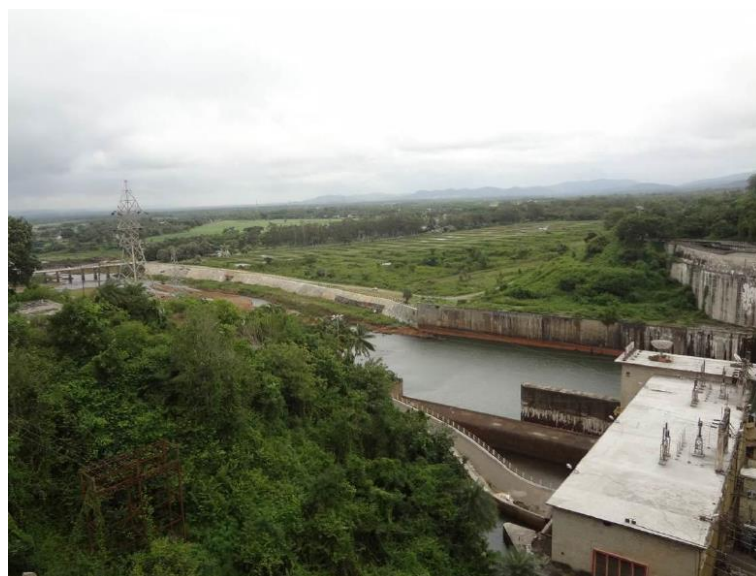
Figure 4.7. View of the right side protection wall of tail channel for left bank after completion of work. Source: CSV20170921.

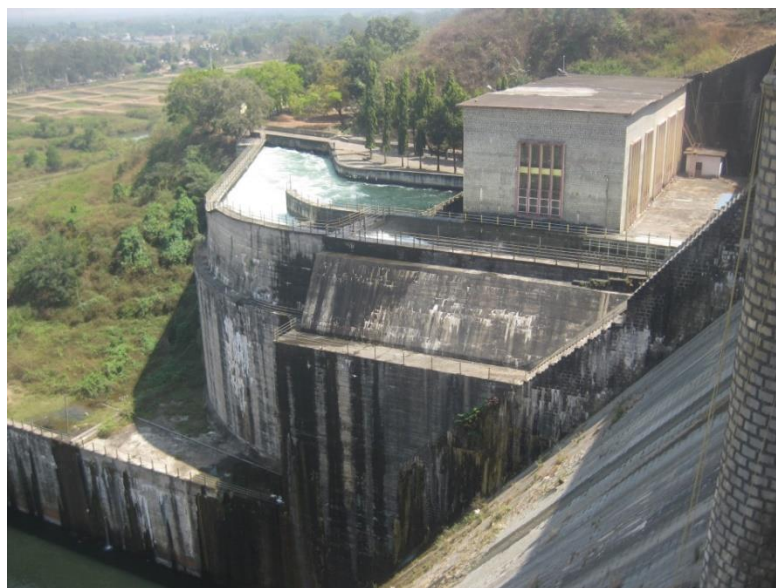
The collapse of the right bank guide wall occurred in 1991. “The Bhadra’s right bank left side guide wall was collapsed suddenly on 18 September 1991 resulting in disruption of the irrigation to Bhadra’s right bank canal and its branch canals.” After this event, saddle dam 4 was converted into a spillway. “After the collapsing of the tailrace training wall at the irrigation sluice of the right bank canal during 1991, to save the standing crops and to ensure continuous irrigation, earthen dam at saddle dam nr. 4 on the right bank was excavated and converted into a chute spillway and was constructed in its location to meet the emergent situation. The saddle dam 4 on the right bank is therefore does not have earthen embankment now.”

Figure 4.8. View of the right bank channel during site visit on 21 February, 2017.

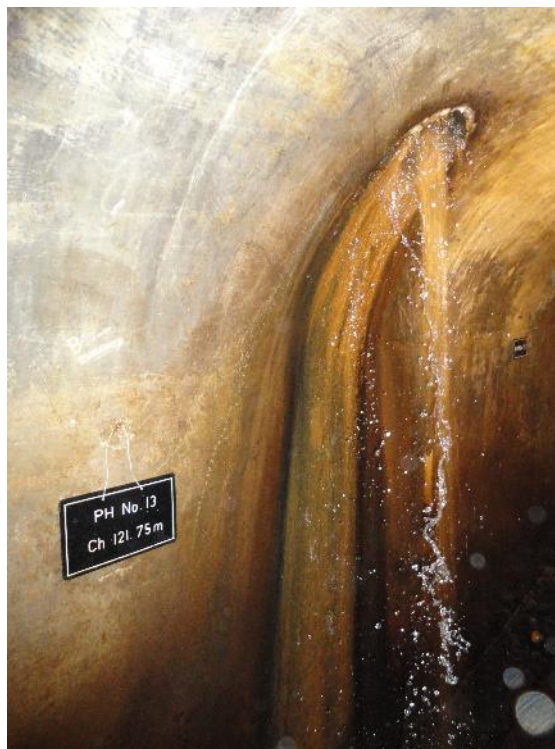
The masonry far left flank monolith shows very little downstream face seepage as stated in PST2015b. Previous work on this section included directional grouting of the monolith and it shows to be effective. The monolith between the left flank monolith and the spillway section has through seepage exposed at various levels, as stated in PST2015b and observed during the site visit. Porous drains are marked with light to moderate leakage (estimated at <50 l/min, PST2015b). However, there are drains that are clogged with calcareous materials.

Figure 4.9. Example of drain at main dam and location mark.

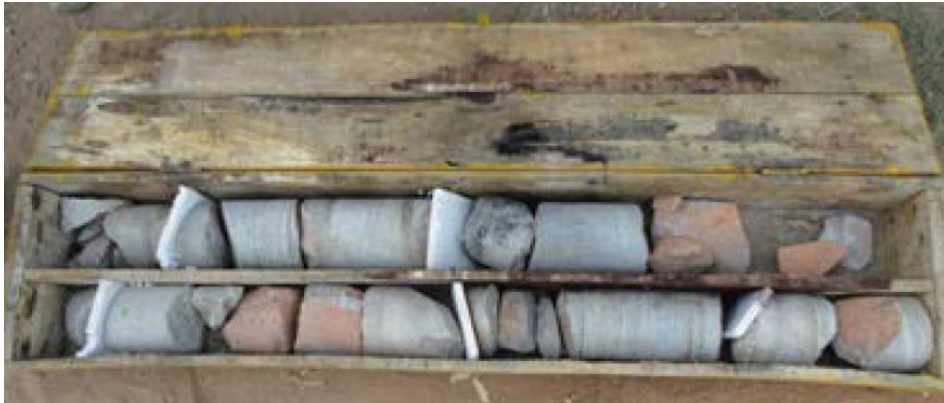
There is no information on quality or resistant parameters of dam body materials in the main dam. There are some obtained from drills conducted in 2016-2017 as shown below.

Figure 4.10. Core samples at main dam. Source: CSV20170921.

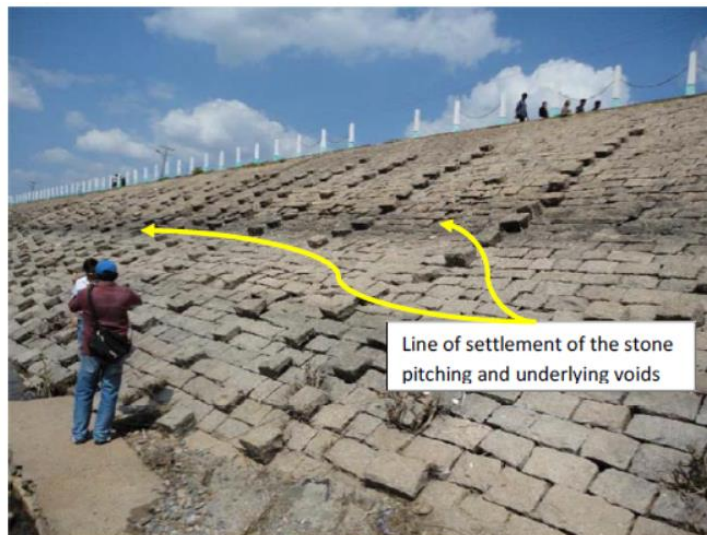
Saddle dams 1 and 2 have significant settlements on the upstream slope and on the left flank of saddle dam 1. At saddle dam 2 slightly uneven settlements are also observed on the upstream face. These settlements are being regularly monitored for the last six years, but their origin is still unknown. A proposal for installing a surface settlement gauges is included under the DRIP project, but has not yet been implemented. These settlements in Saddle Dam 1 can be observed in the following picture:

Figure 4.11. Settlements observed in upstream face of Saddle Dam 1. Source: Technical inspections.
