TKI Dotter-project

Towards coupled risk-based aquatic vegetation management and EU-WFD-targets

Report - Final

April, 2017

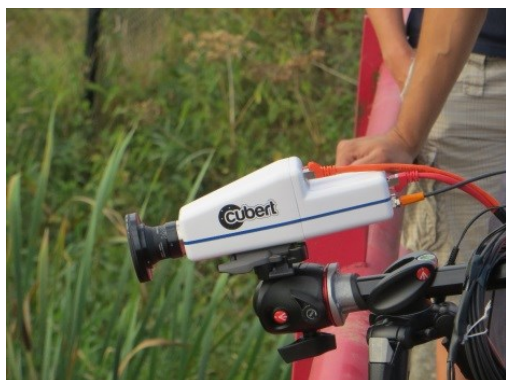
Figure 3.1. The Cubert UHD 185 - 'Firefly' full spectrum camera.

During the definition phase the appropriate equipment needed for the project was selected and acquired. A full spectrum camera (UHD 185 - 'Firefly'; Figure 3.1) from the firm Cubert was selected for further testing in this project (technical details of the camera can be found in Appendix A). This camera has the advantage that it takes both a high resolution (1000*1000 pixels) black and white image and 138 low resolution (50*50) spectral images from 450 nm to 998 nm in steps of 4 nm bandwidth. These two types of data can be overlaid to get more details.

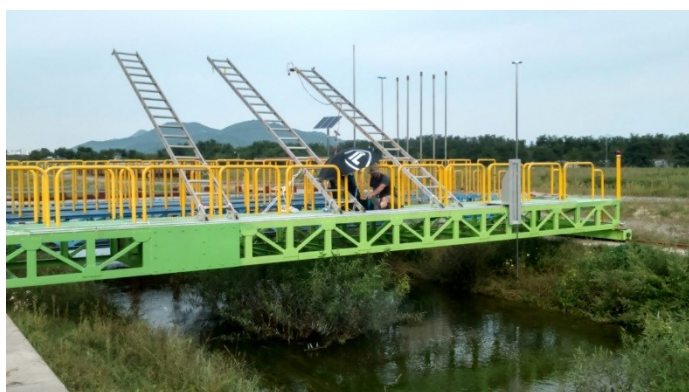
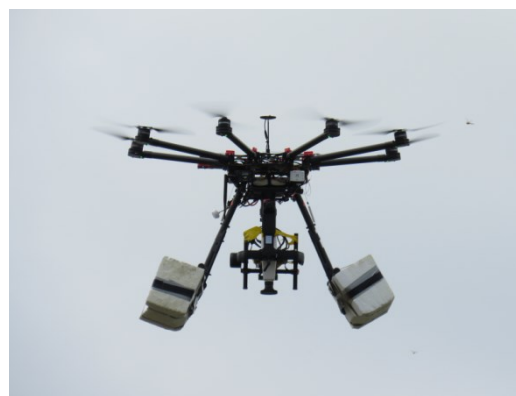
Figure 3.2. The REC experimental set up with a. camera on fixed ladders, and b. on the UAV

The REC experimental set-up in the A1 channel consisting of four dense patches and three sparse patches, was prepared by KICT and KICT-Joint Venture in the summer season. Detailed flow measurements were carried out for this year's (2016) set-up using ADVs and ADCP equipment for a setting with 1 m³/s discharge and a maximum water level (downstream weir at maximum height). This set-up was used to test (Figure 3.2):

- The ability of the camera to distinguish between densities and vegetation types: One vegetation type consisting of young willows, with two densities, covering a set of patches in the channel. At the same time, naturally growing vegetation along the sides and on the bed of the channel was also photographed.
- The effect of varying water levels on resulting images. Water levels were adjusted from empty bed to bankfull. During these water level changes pictures were made and the water height was recorded. This procedure was repeated.
- The ability of the camera to deal with turbidity: images were obtained while changing the turbidity of the water by manually adding a sand mixture to the stream. Suspended sediment samples and PAR measurements using a LiCOR underwater light meter were recorded to link the images to related turbidity equivalents.

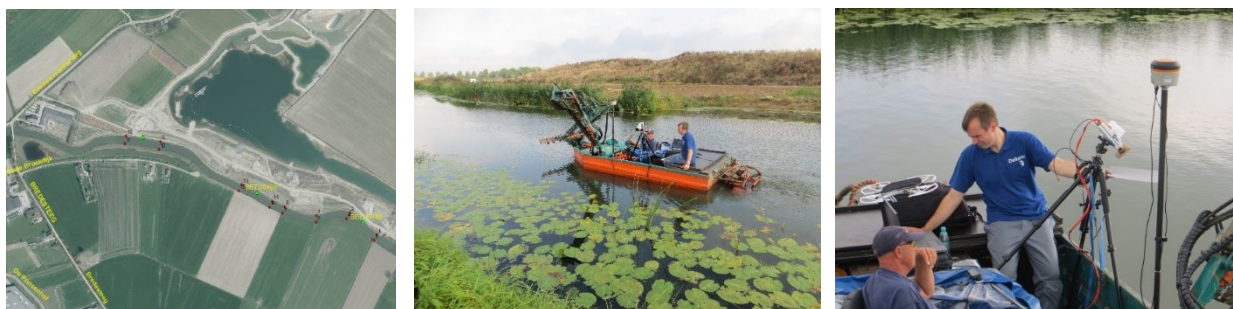
Figure 3.3. Test site De Linge, near Echteld in the Betuwe district of Water Board Rivierenland.

This visit was the first time we deployed the full spectrum camera in the field. The main emphasis of the visit was to experiment with the camera settings, use of additional polaroid filters and understanding the software used to manage the camera (Figure 3.3).

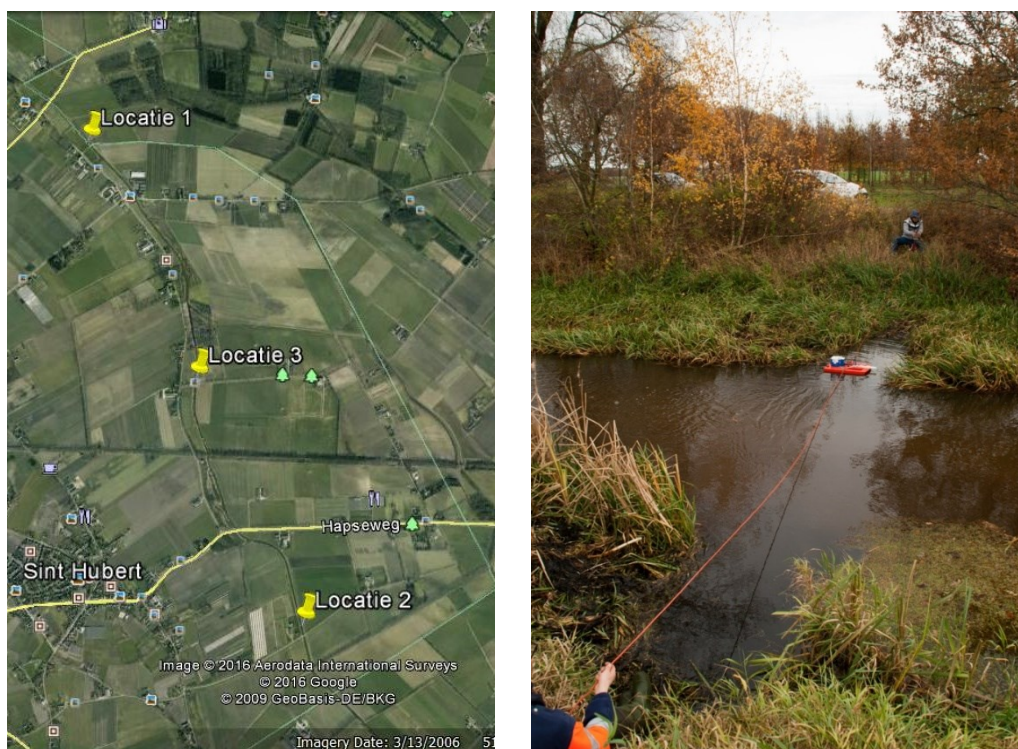
Figure 3.4. Locations at the Lage Raam (left) and ADCP flow measurements at location 3 (right).

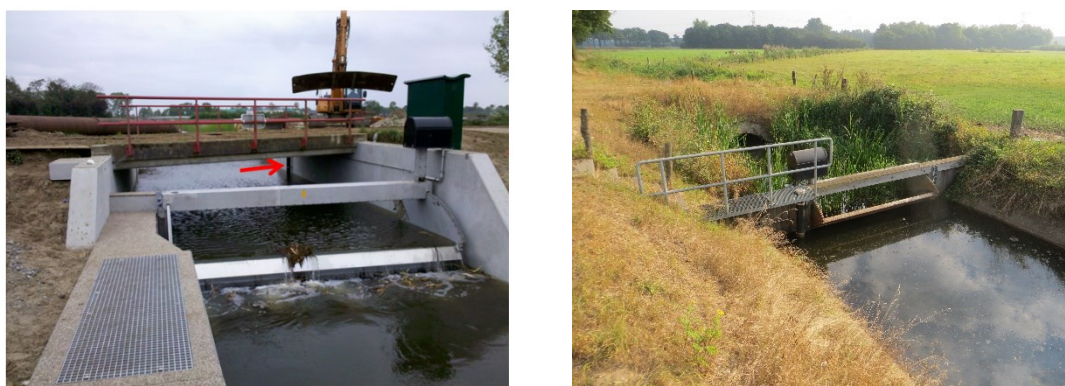
Figure 3.5. Location 2 IJzerbroek weir (108IJZ; main water course, left) and 108TDE weir (tributary, right) in Lage Raam water system, Aa en Maas, near Mill. Red arrow points at measurement location of upstream water level.

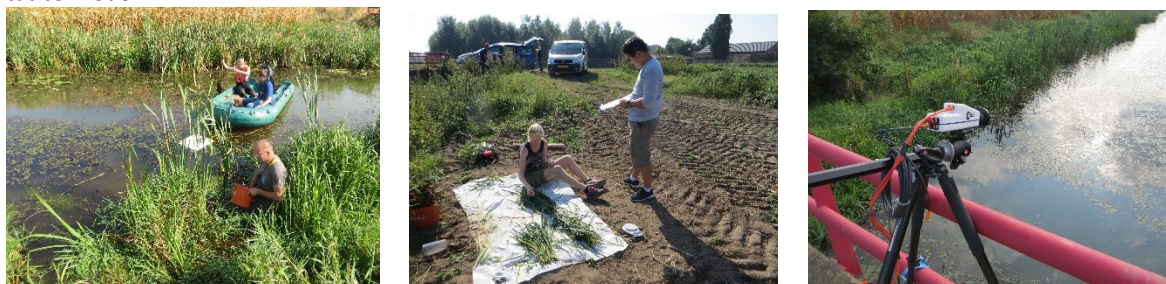
Figure 3.6. Field observations in Lage Raam water system, Aa en Maas, near Mill location 1. Date: September 15, 2016.

A EU-WFD-proof vegetation mapping was carried out as well (Figure 3.6). Due to the absence of sufficient discharge on September 15, 2016, stream flow velocity was delayed to the 15th of November (ADCP, StreamPro).

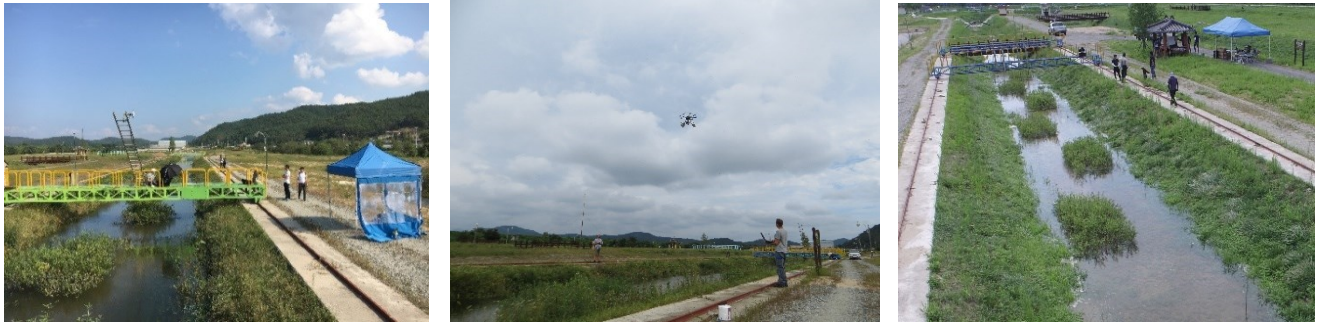
Figure 3.7. River Experiment Center (REC) of KICT at Andong, Korea.

From September 22 to 29, 2016, we used the straight A1 channel including its patches of vegetation to test the spectral camera. We started with a fixed position on the railing bridge across the test channel. At the end of the field work, we used a Korean UAV/RPAS with the spectral camera mounted to take pictures from the same section during flight (Figure 3.7).

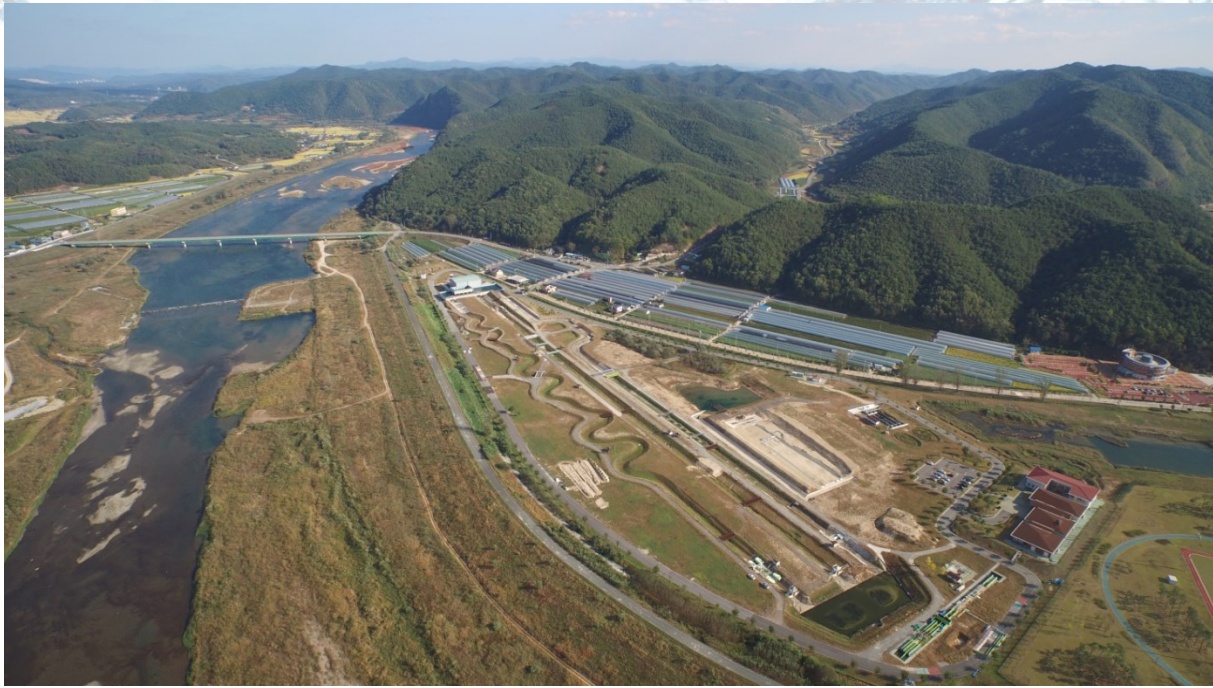
Figure 3.8. Aerial image of the full River Experiment Center, with the Nakdong River next to it.

The River Experiment Center (REC) of KICT in Andong, South Korea, is an excellent site to test and calibrate/validate vegetation mapping under controlled conditions (Figure 3.8). Established in 2009, the Center is capable of scale 1:1 tests in three prototype channels of 600 m length and 11 m width at maximum. Its pump capacity leads to stream discharge rates up to maximal 10 m³/s. Two test channels are straight water courses, while the third channel is meandering with different sinusoidal levels.

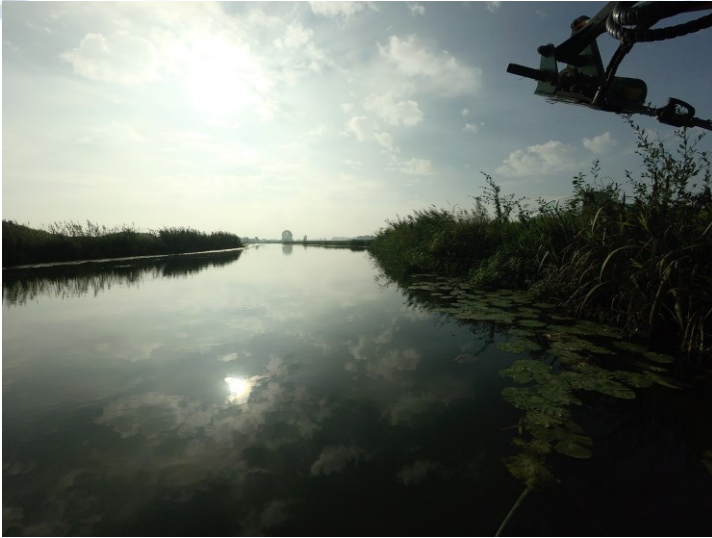
Figure 4.2. Illustration of strong reflections by the water surface.

Although the spectral images do not provide a good coverage, the field work contributed a lot in the development of the method. It was found that under sunny conditions with small clouds it is very hard to visualize vegetation below the water surface due to the strong reflections caused by the sun and clouds. Figure 4.2 shows a picture taken with a regular camera to illustrate this effect.

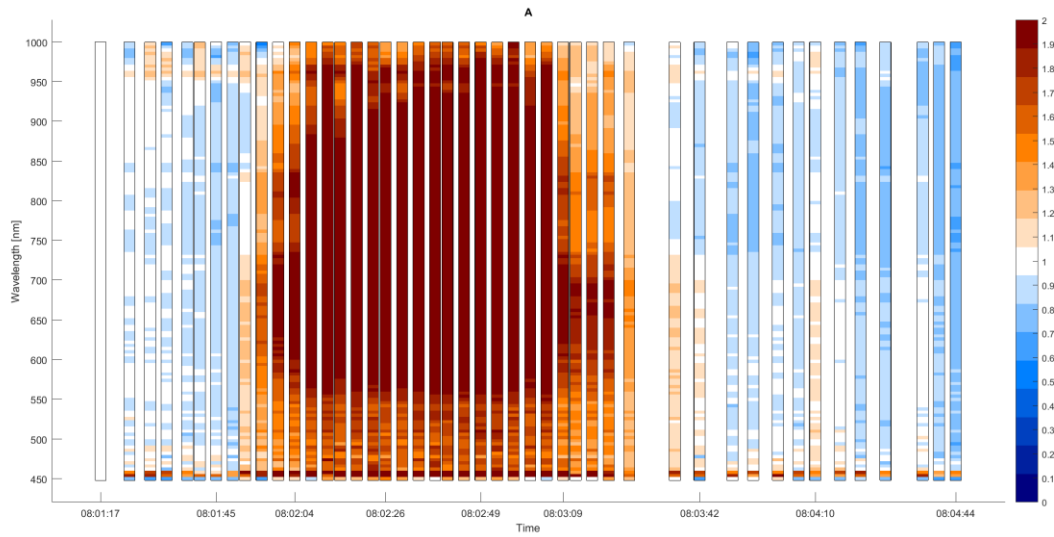
Figure 4.11. A-D turbidity effects over time (x axis) on the reflectance spectrum of all wave lengths (y axis) for 4 different pixels from the deeper section A to the shallow near shore section G. A full set of images can be found in Appendix D.

In order to test the effects of turbidity on the image quality a set of images was taken from a fixed position while turbidity levels were varied by adding inorganic suspended load to the water (Figures 4.10 and 4.11).

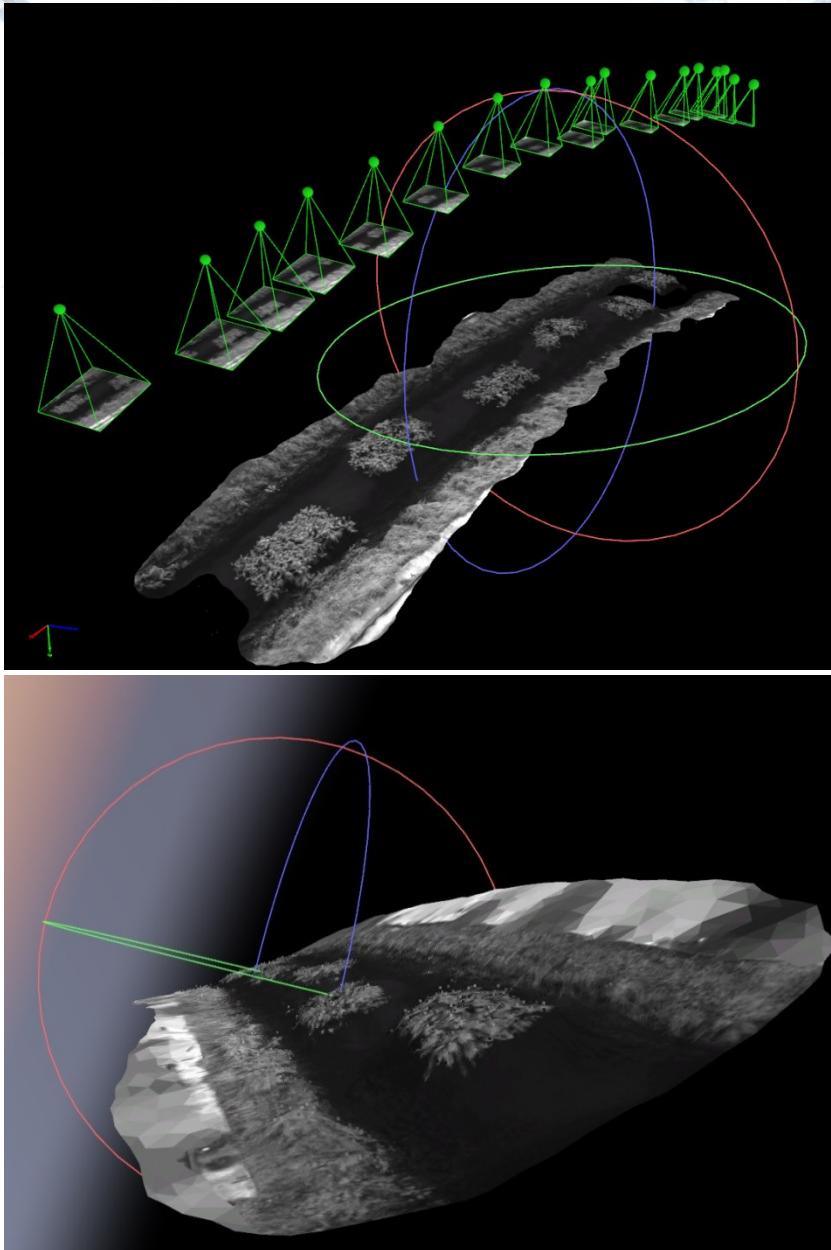
Figure 4.14. Two examples of Pix4D results for a 3D model of the UAV images @REC.

The drone images acquired at the REC were the only images that Pix4D could use to generate a 3D model. Some results are presented in Figure 4.14.

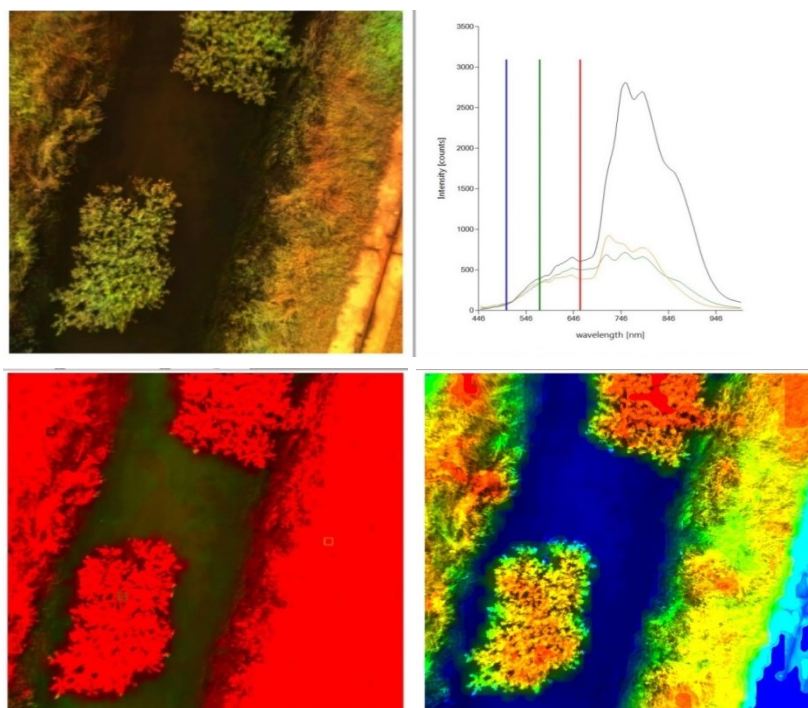
Figure 5.1. Pseudo full colour image from one UAV picture, a spectral image of the picture for 1 nm band and the resulting NDVI index.

After normalizing the raw spectrum data, NDVI and other clustering algorithms can be applied. The spectral images can be processed individually, which gives results as presented in Figure 5.1: a pseudo-colour image based on RGB colour bands, or individual spectrum lines (e.g. the red image line below). Also, Cubert software allows for some automated calculations of common indices such as the NDVI index (bottom right).

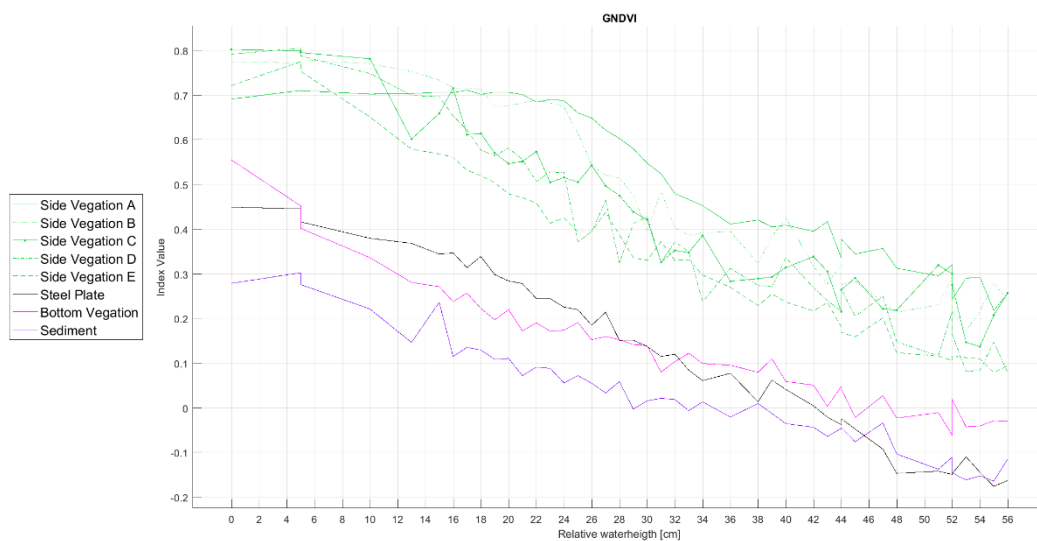
Figure 5.3. Response of different indices to changes in water level.

Response of these indices on changes in water level and turbidity were assessed (all results are included in Appendix D). It was observed that some indices respond stronger to these changes than others. In Figure 5.3 (three images) a clear difference was observed between the vegetation and the group of pixels representing 'steel plate, bottom vegetation and sand', with the GNDVI decreasing for both groups with an increasing water level, and the PSRI increasing with an increasing water level, while the ARI1 did not make a good distinction between the vegetation and other materials nor responded well to changes in water level.

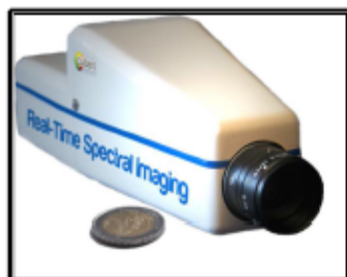
1 UHD 185 Dragonfly

Technical specifications UHD 185 „Dragonfly“

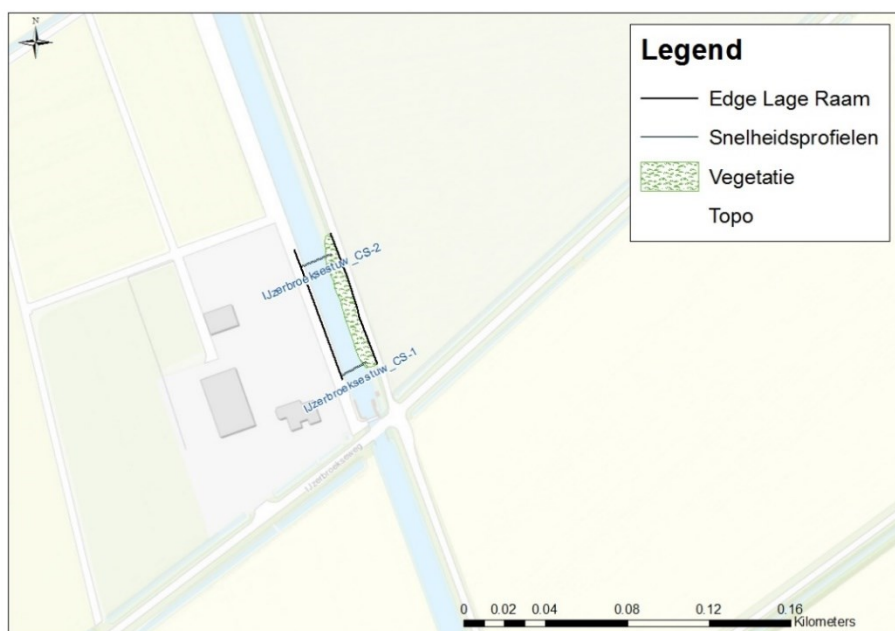
Figuur 0.2 Detailkaarten van de twee veldwerklocaties

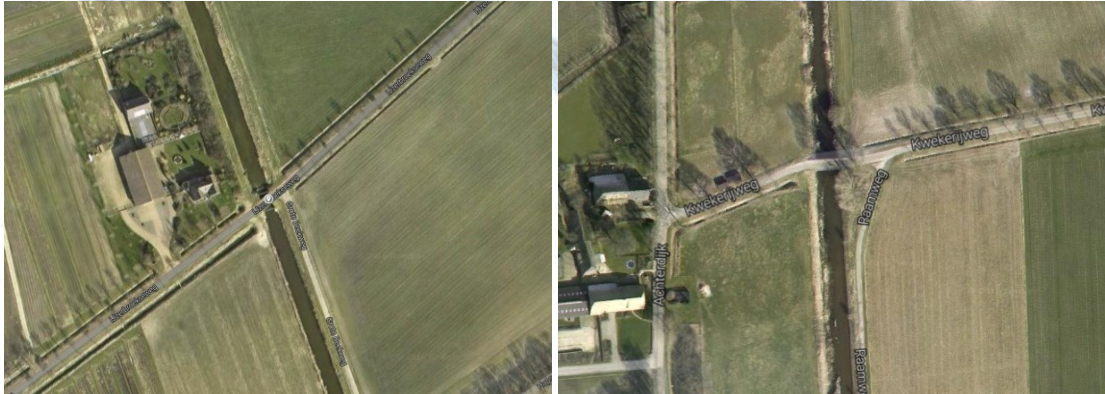
Site #2-downstream of weirs (N51.676498, E5.827559) Site #3-upstream of the bridge (N51.688578, E5.816463)

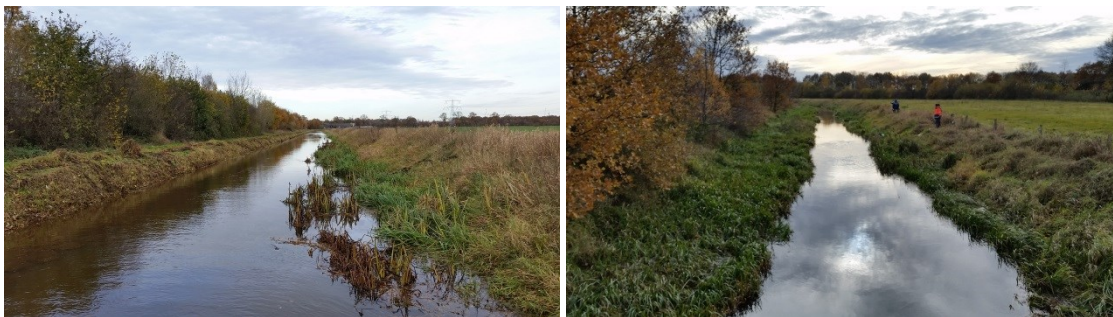
Site #2 (looking downstream)

Site #3 (looking upstream)

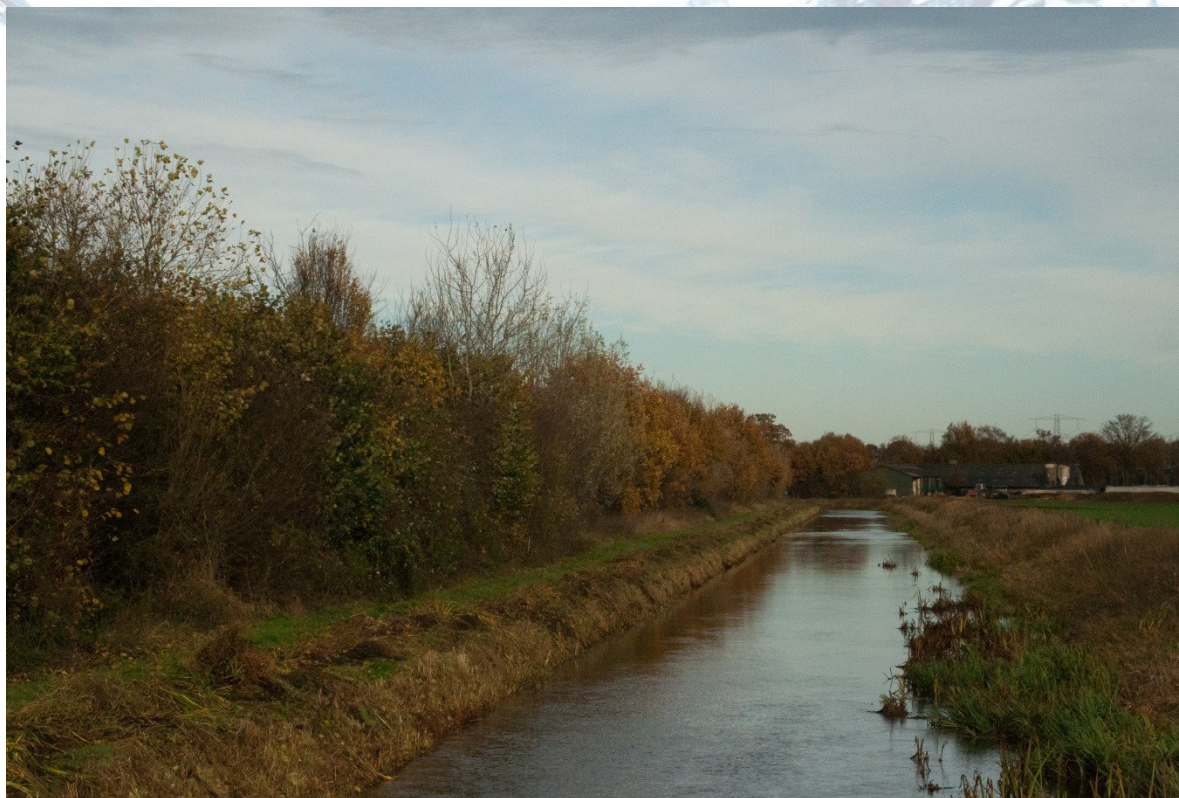
Figuur 0.4 Site #2 genomen vanaf de stuw stroomafwaarts gericht.

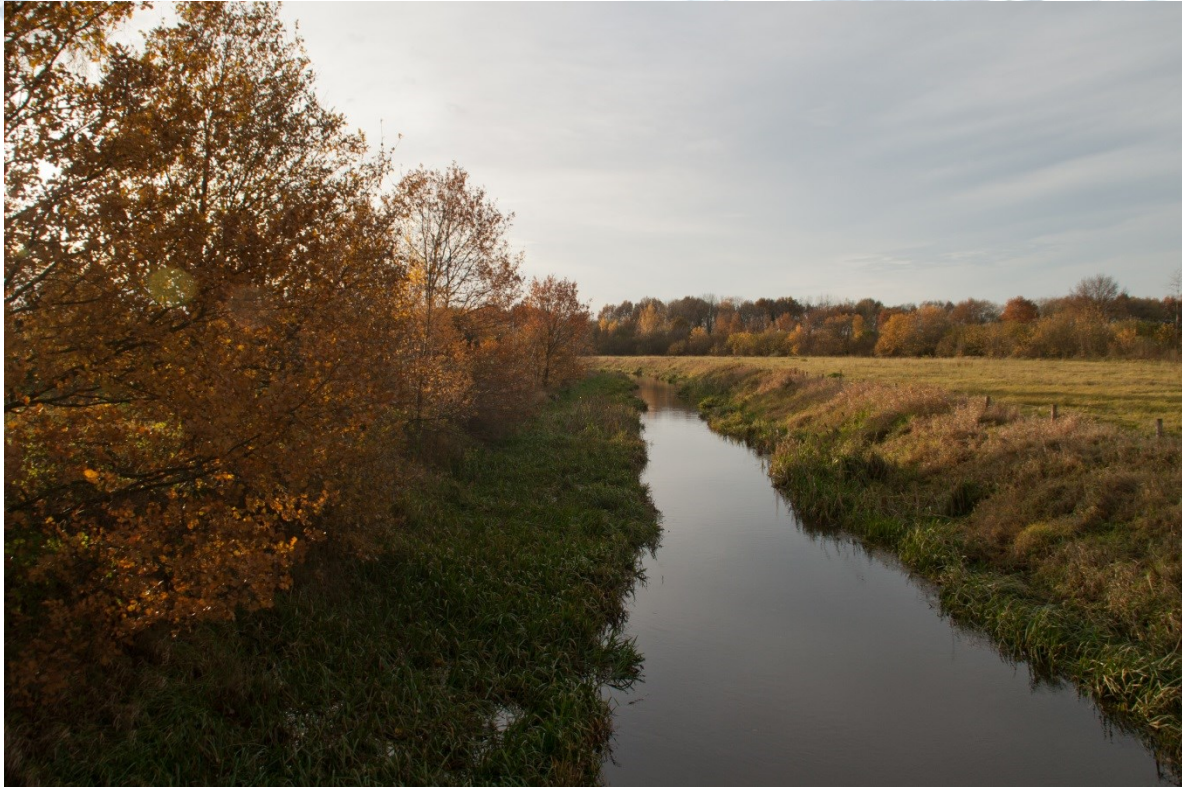
Figuur 0.5 Site #3 genomen vanaf de brug stroomopwaarts gericht.

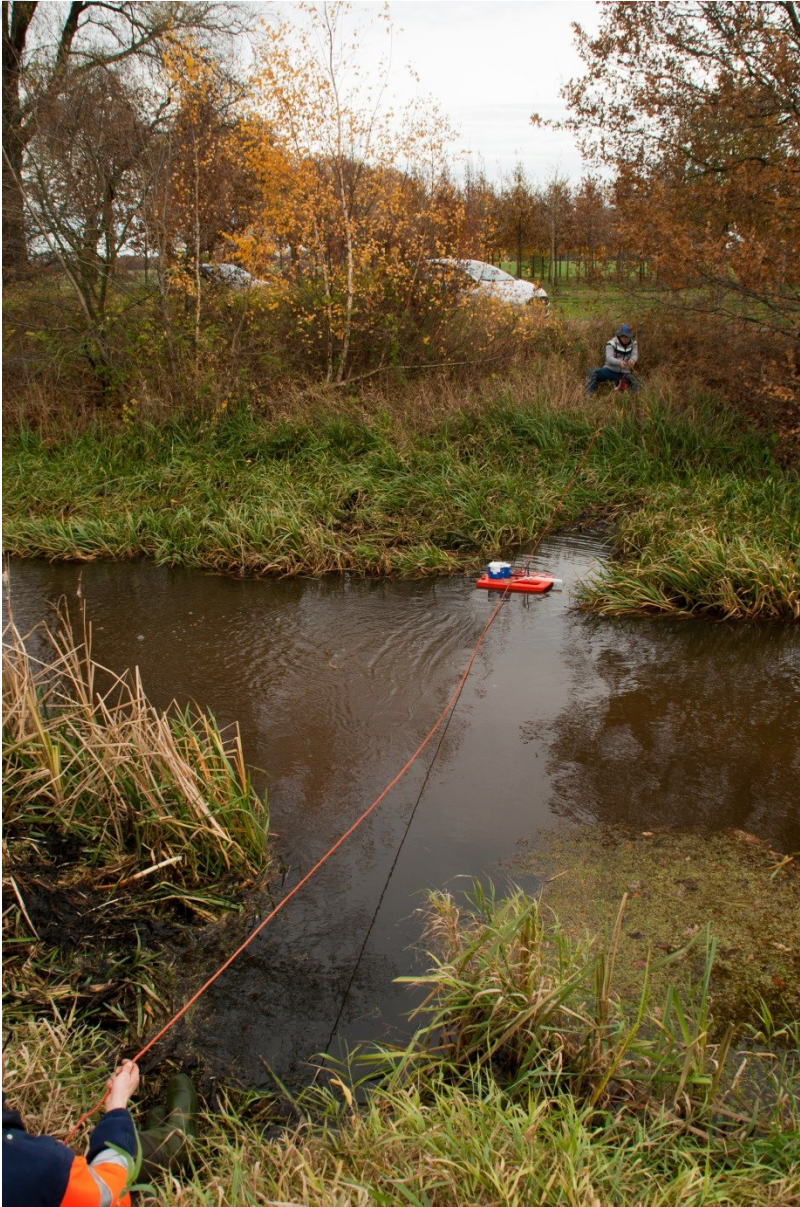
Figuur 0.6 Site #3, profiel 1, voorbeeld van het uitzetten van een traject voor de StreamPro.
