## Morphodynamics of sand nourishments (sand engines) in eroding sections of the Rhine-Meuse Delta

13th Symposium on River, Coastal and Estuarine Morphodynamics  
RCEM 2023

**Kees Sloff (presenter)** – Deltares / TU Delft

25 September 2023

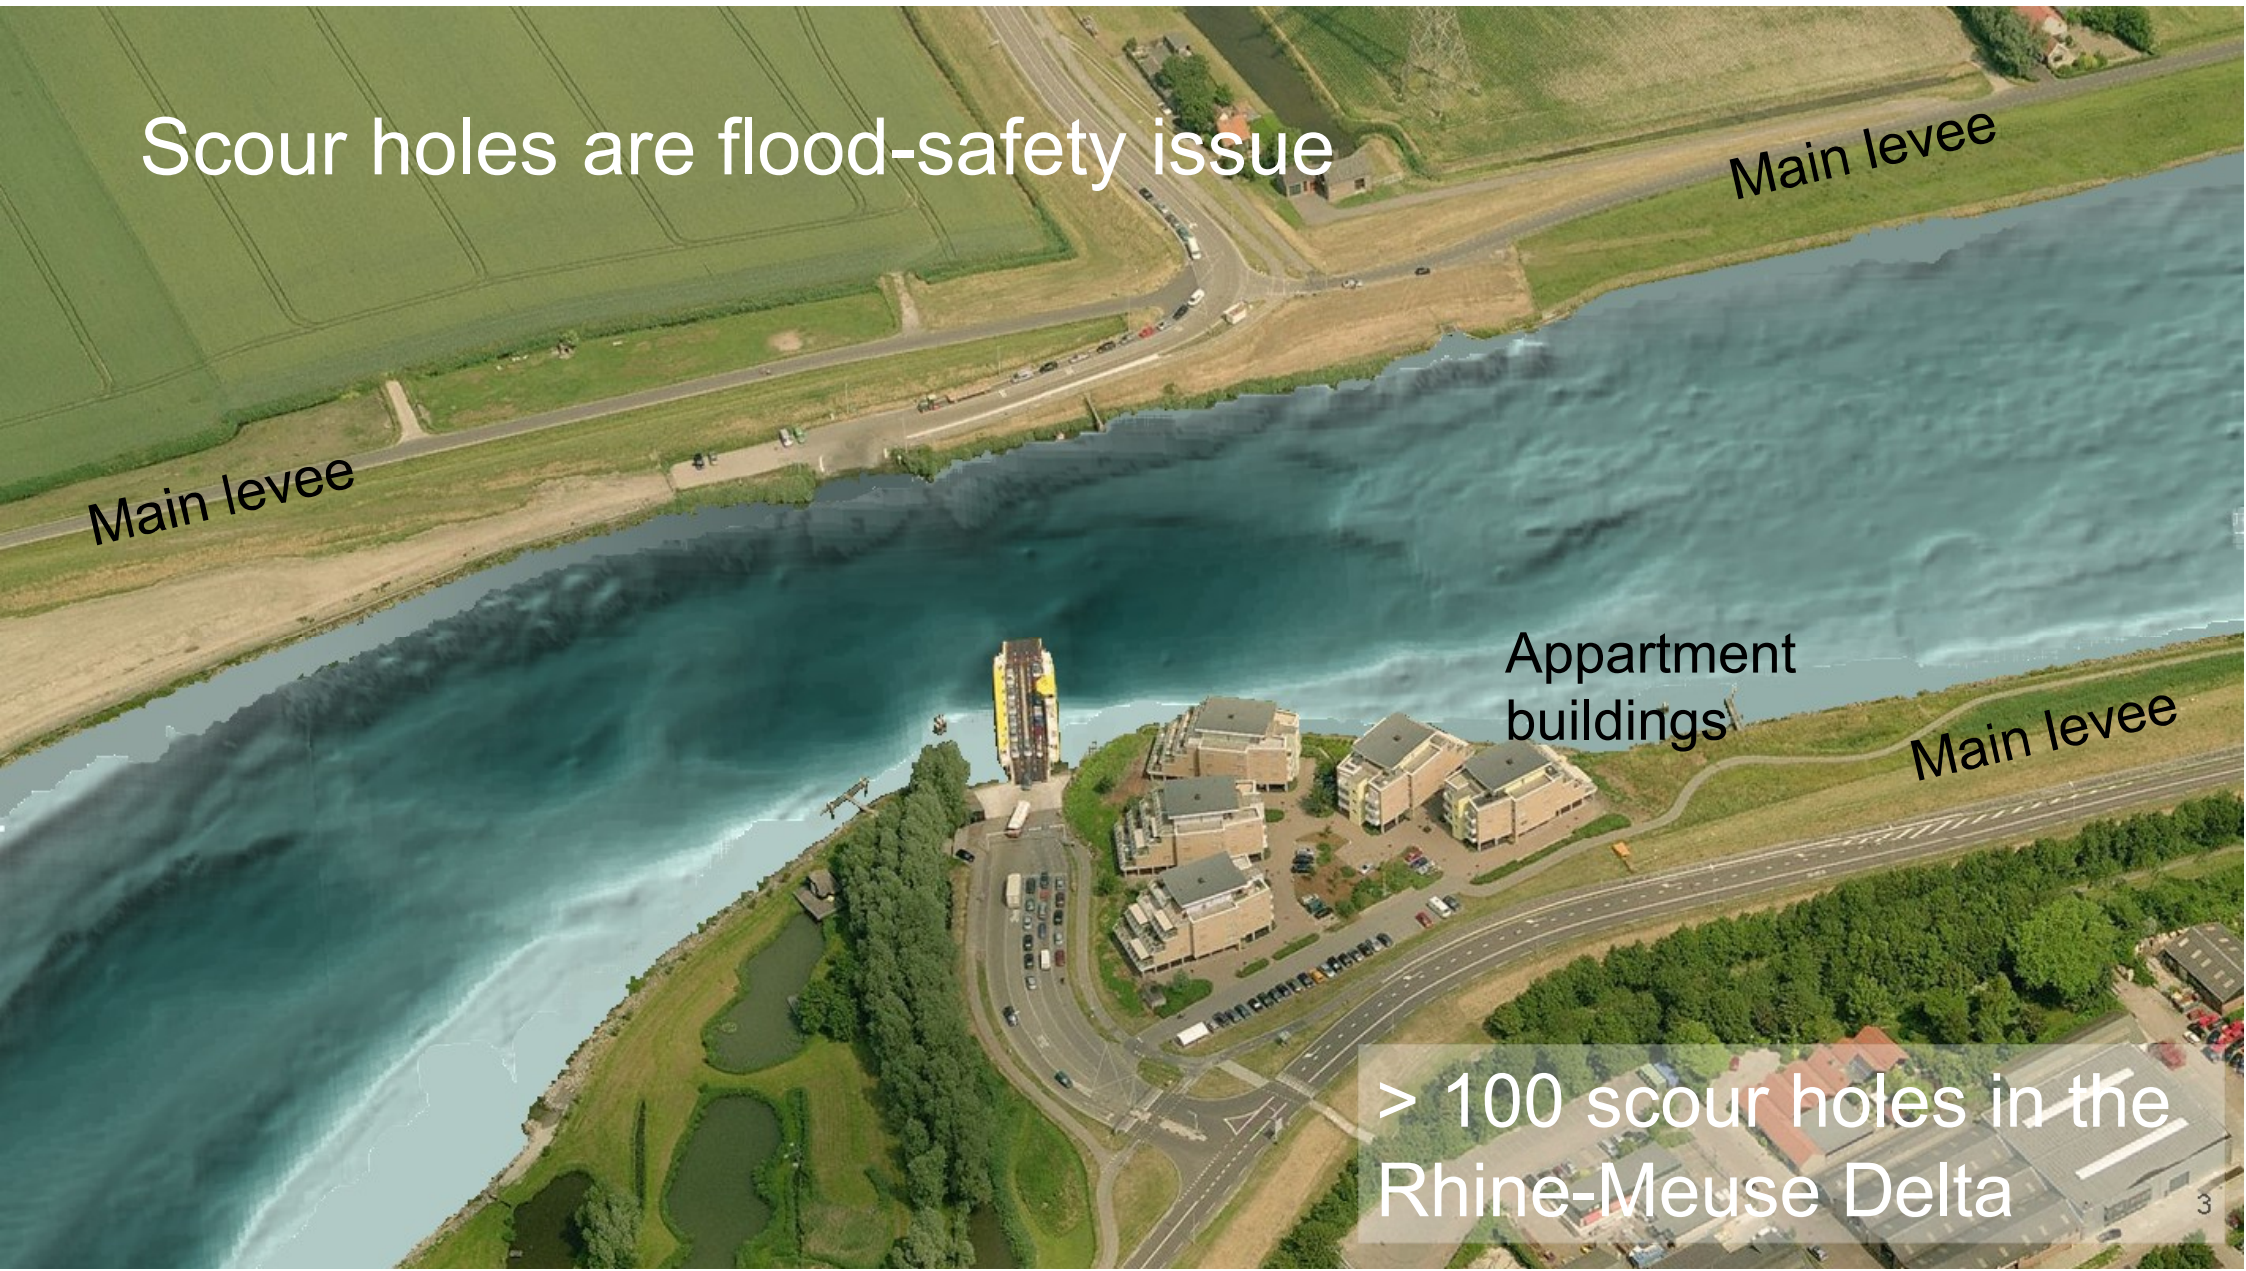
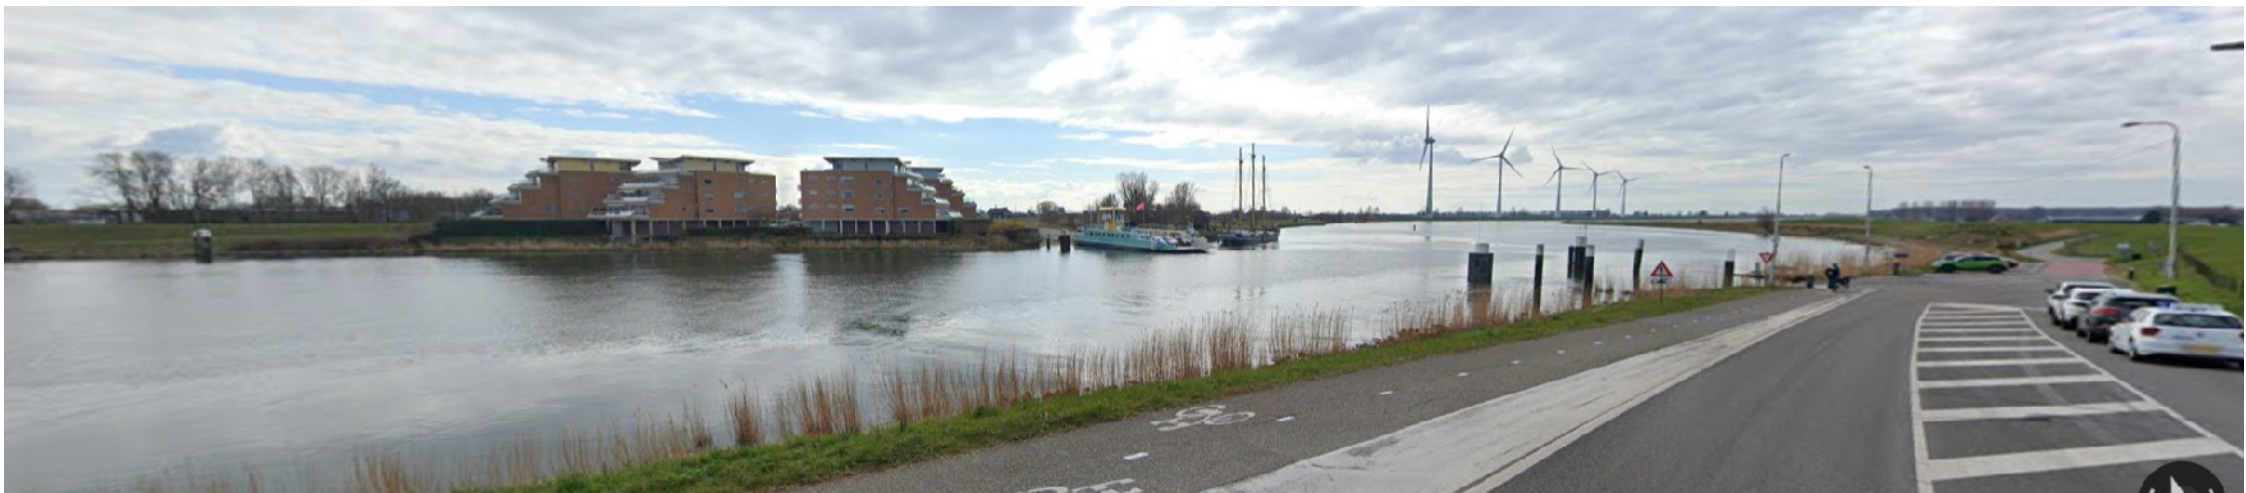
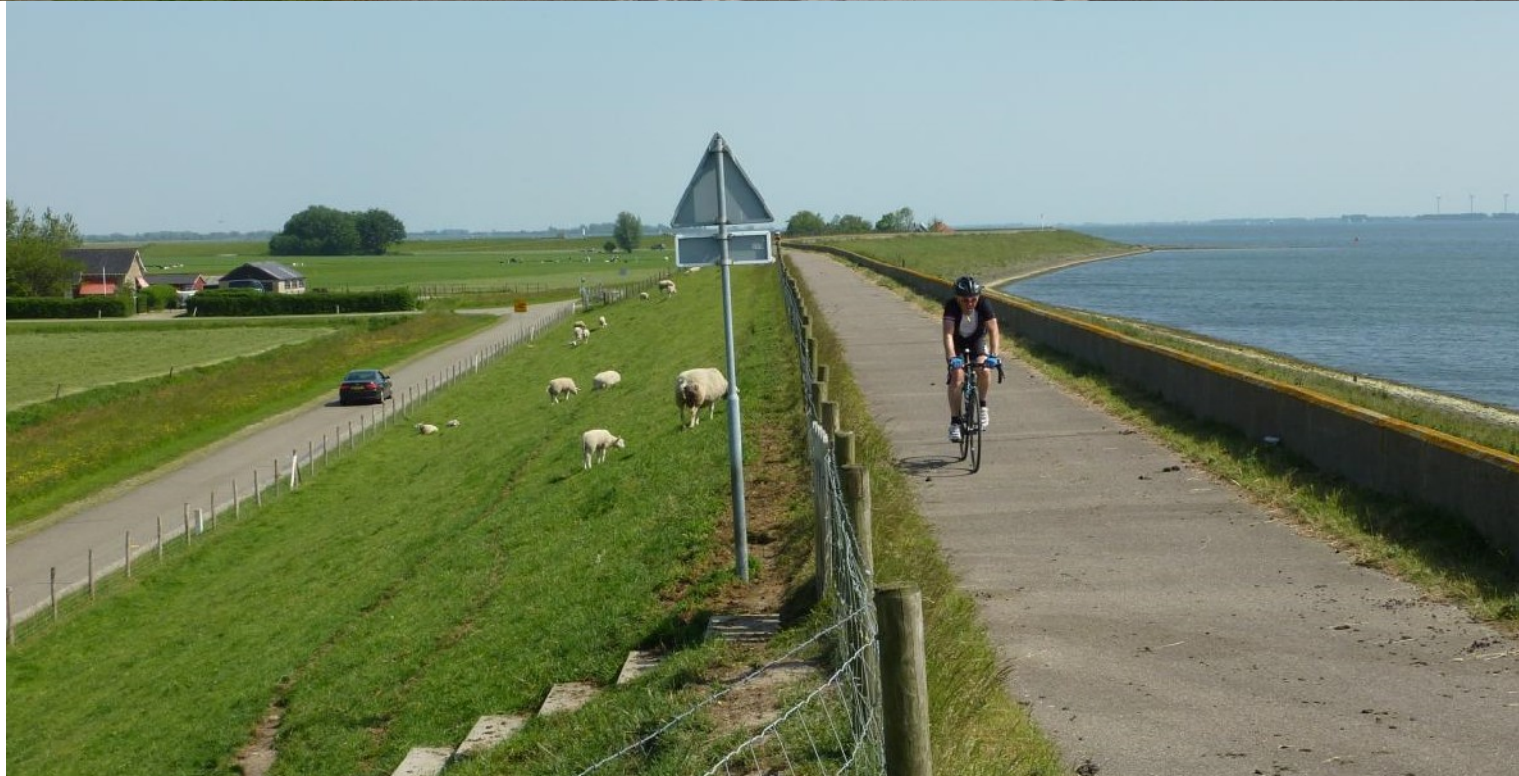
# Scour holes are flood-safety issue

> 100 scour holes in the Rhine-Meuse Delta

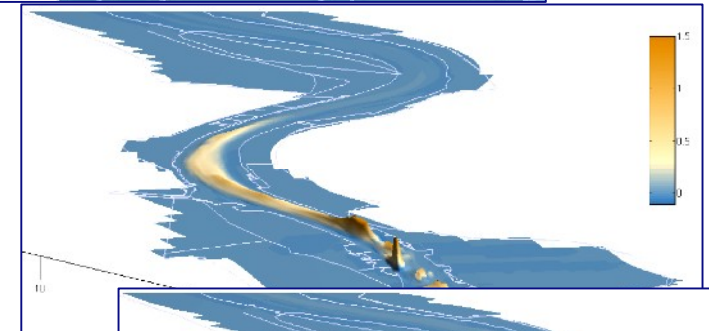
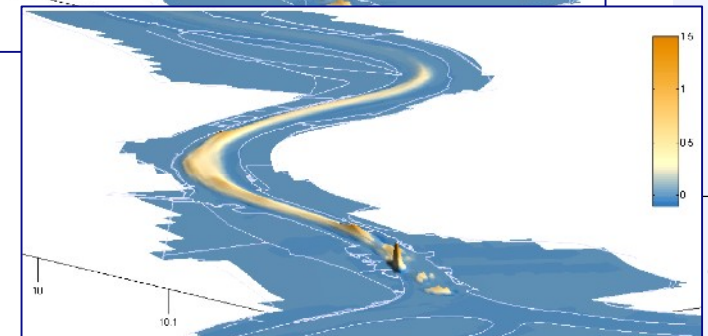
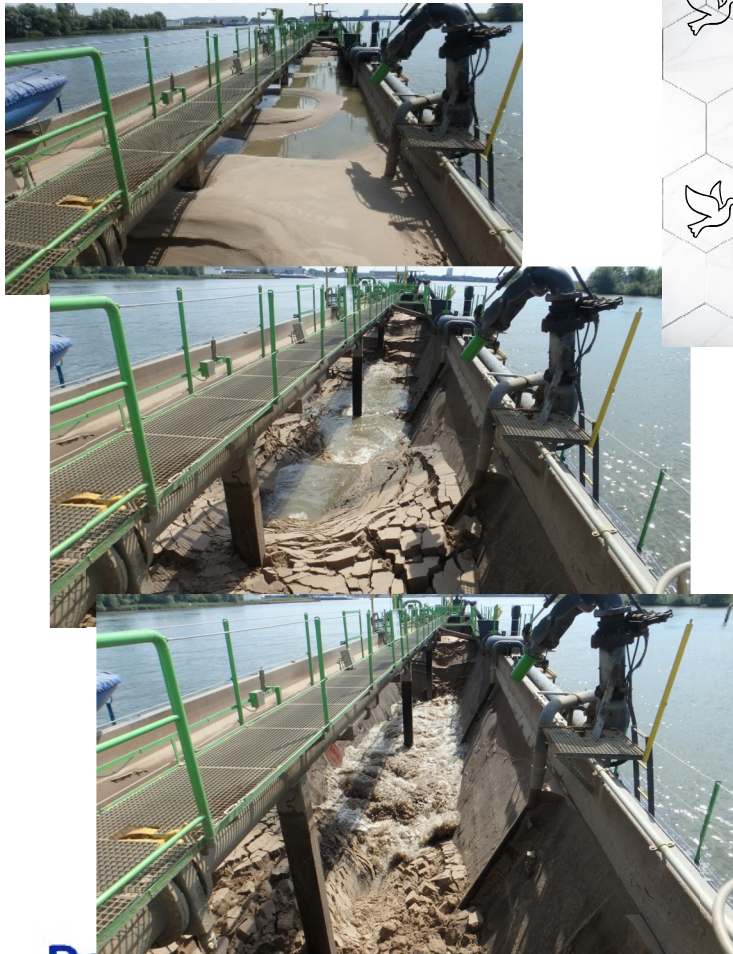
“Sand engine”  
Numerical  
simulation  
Delft3D

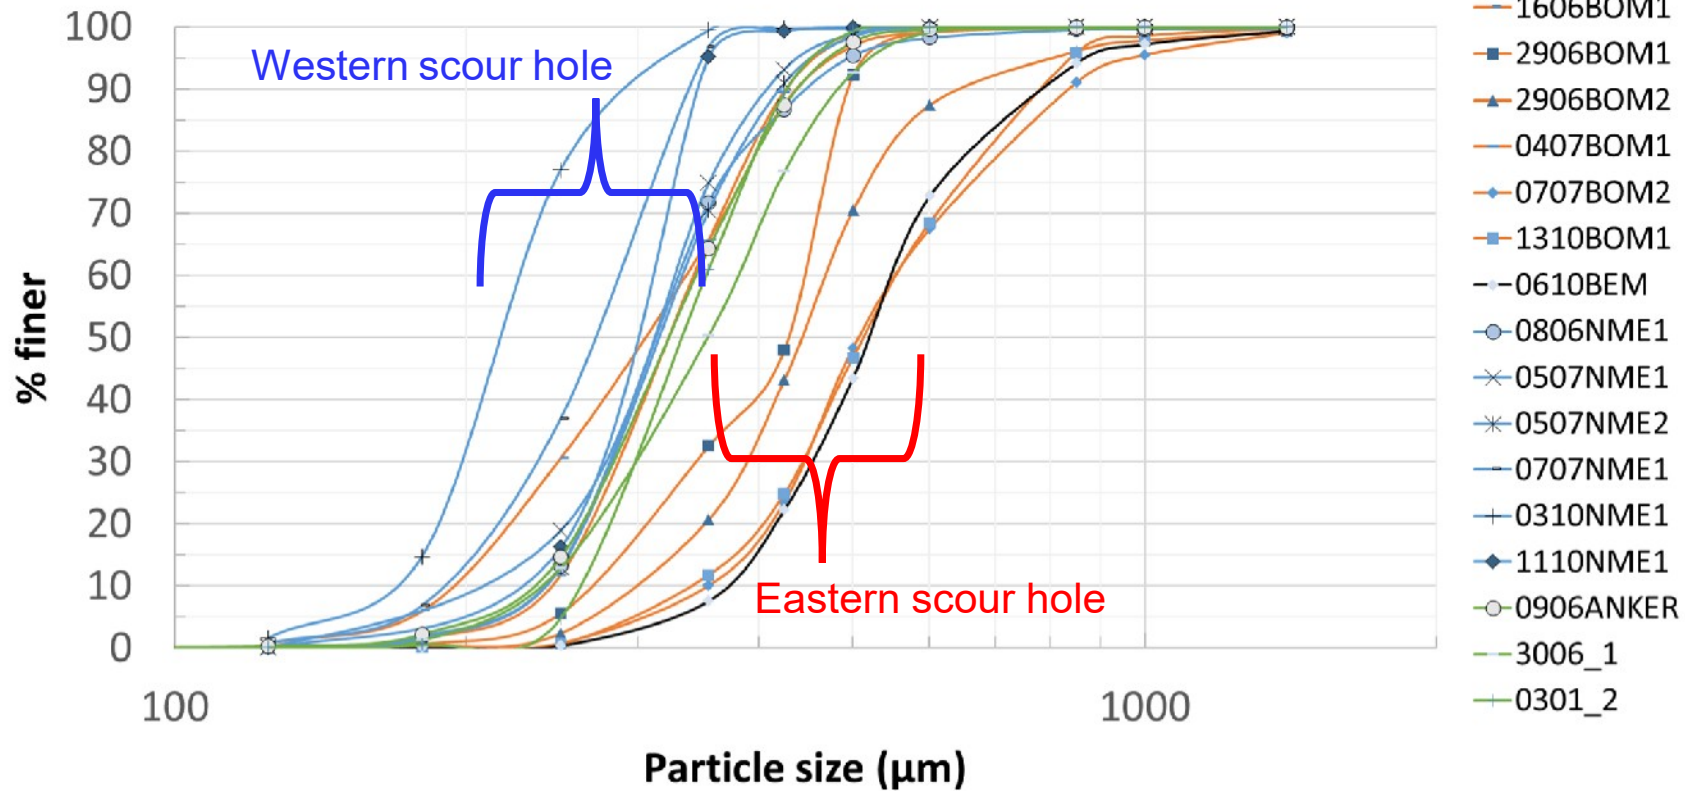
Zeefkrommes gebaggerd materiaal van BOM, BEM, NME en overige

- Samples taken from the hopper

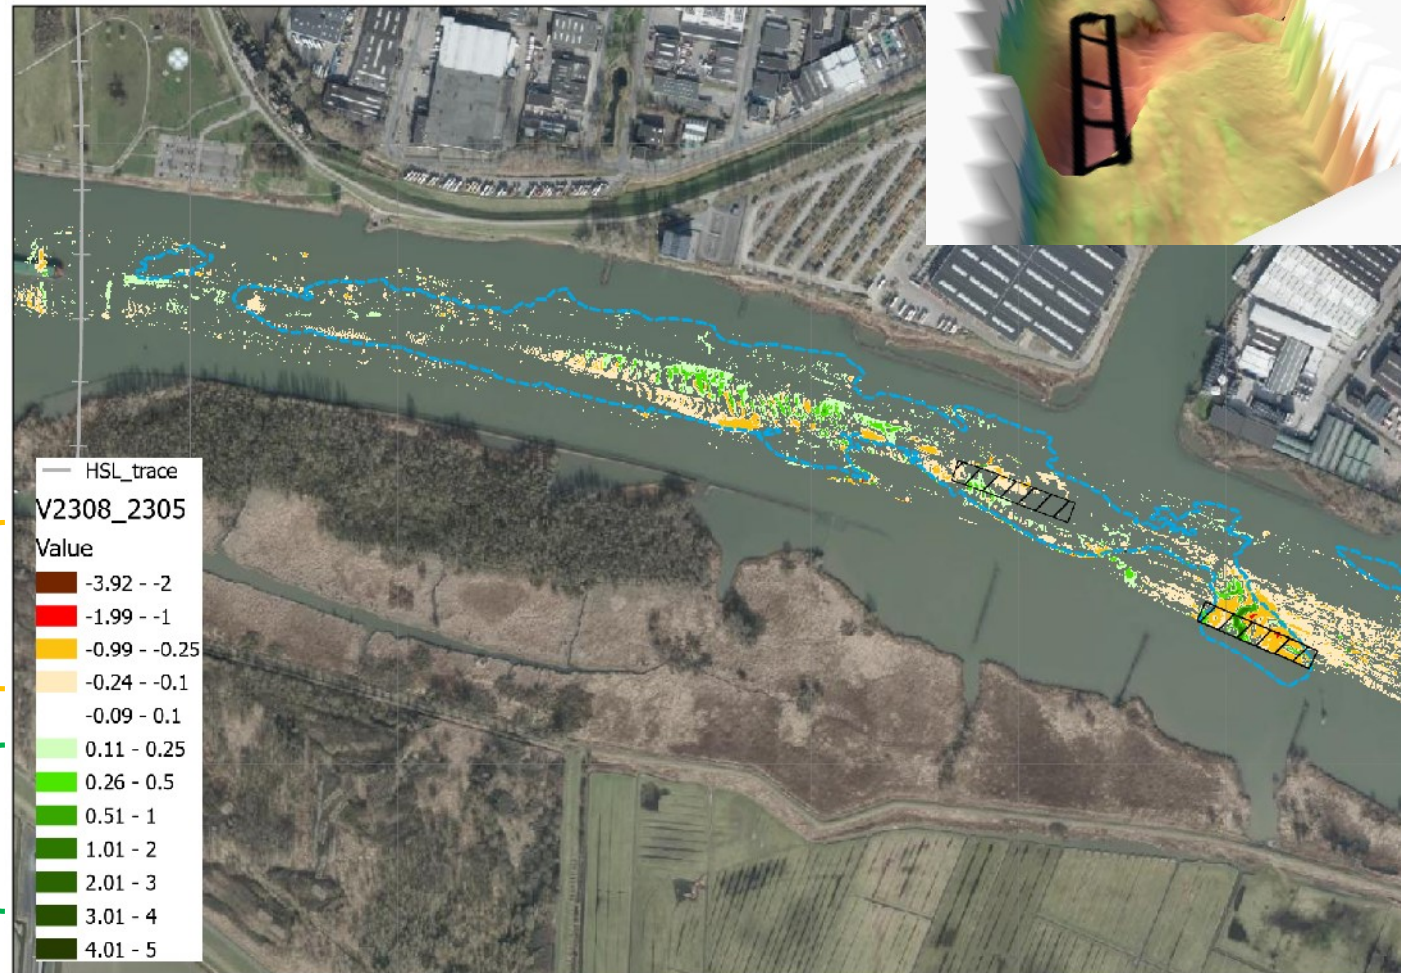
2<sup>nd</sup> nourishment was placed only in the Eastern scour hole

- Not much sediment seems to leave the scour holes
- Sand engine slowing down?

August 2023 minus April 2023 (after 2<sup>nd</sup> nourishment)

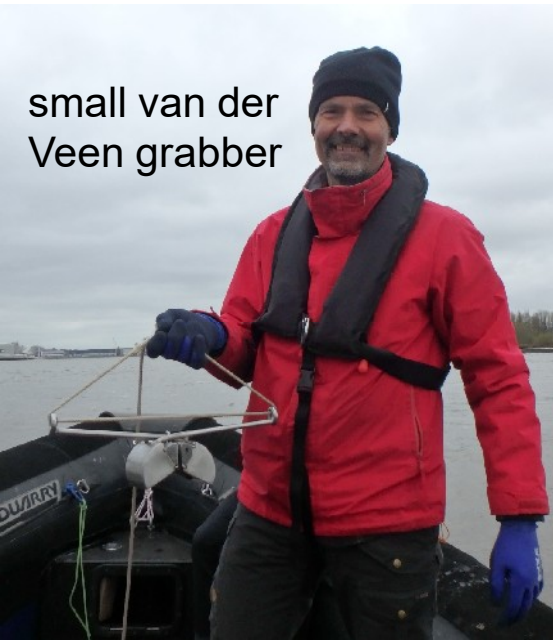
# Post nourishment bed-sediment sampling (7 April 2023): unintended catch

**Corbicula fluminea (invasive Asian clams) & some sand**

**Nabil Majdi (2014):**  
***C. Fluminea* causes effective bioturbation (biodiffusor)**

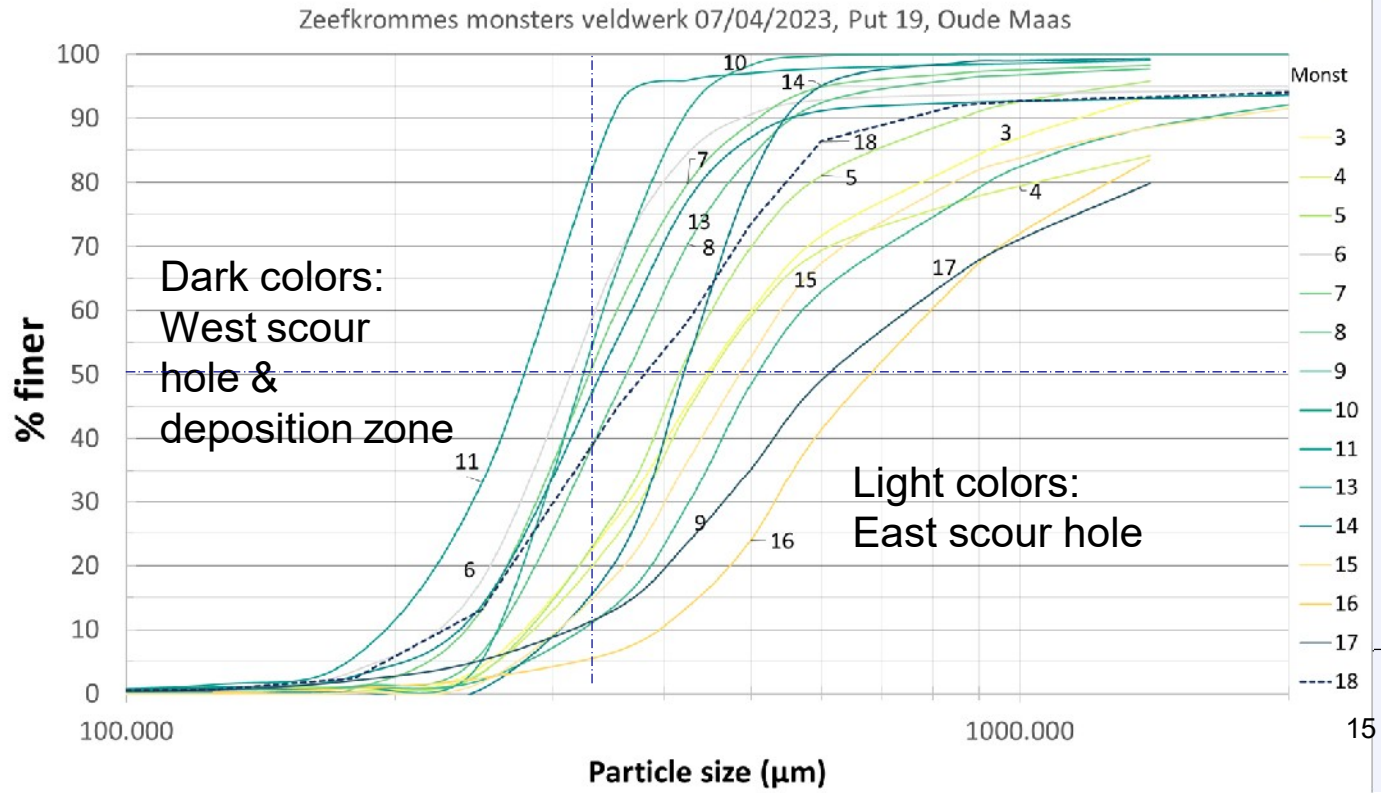
- Coarsening of sediment in the scour holes
