## **D1.1 Mission report Bhadra dam and reservoir Karnataka, India**

**Deltares in cooperation with iPresas, SkyGeo and Royal  
Eijkelpamp**

11200775-001

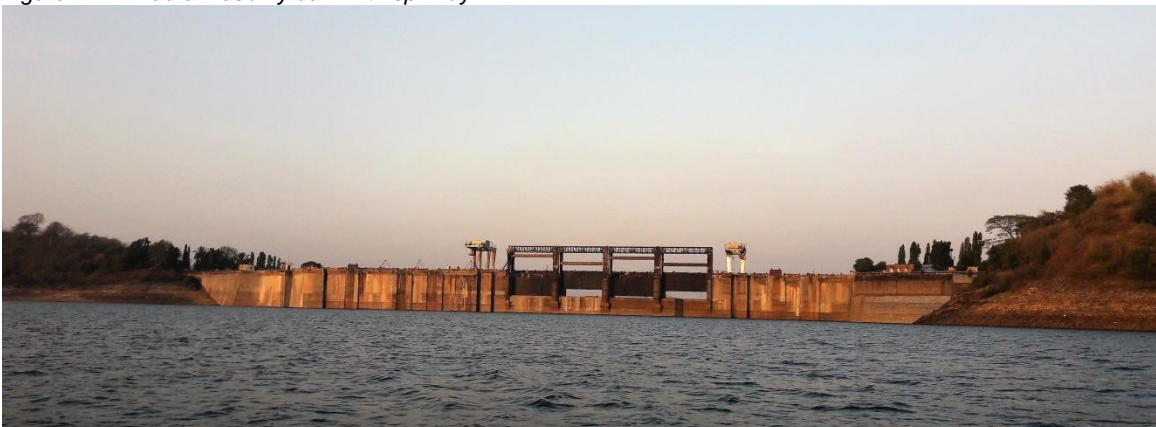
Figure 2.2 Bhadra masonry dam with spillway

- As stated in the technical note and observed during the site visit: “Seepage through the foundation drains in the gallery and quite excessive quantity of seepage is noted through the porous drain No. 5. It indicates that there is seepage through the masonry section of the dam which is also indicated by the downstream face wetting of the entire dam section and this should be monitored for taking remedial action.”

- Based on outcomes from the safety review in 2014: “The dam masonry appears to have become pervious in the above reach through which the water is finding access from the reservoir as evidenced from the seepage and jetting appearing in the dam masonry and besides there is considerable lime leaching observed on the downstream face of the dam in the above reach as a result of which loss of strength of the masonry is apprehended. It is therefore necessary to determine permeability of the existing masonry”.

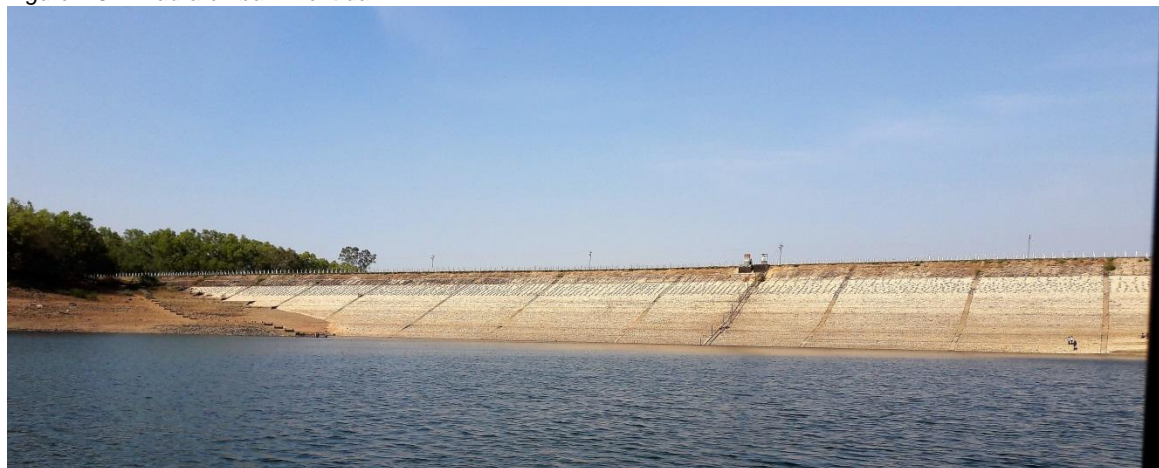
Figure 2.3 Bhadra embankment dam

- An inspection of earthen dams at saddle dams 1 and 2 was conducted in 2002, and it was found that the sections adopted for earth dams appears were quite stable and well maintained.
- However, at Saddle No 2 slightly uneven settlements are observed on the upstream face. This settlement has been regularly monitored since last six years. Proposal for installing surface settlement gauges is included in the dam safety programme, but not yet implemented.
- The cause for the settlements on the left flank of the Saddle No. 1 is still unknown.
