## Dam risk analysis for Bhadra dam and reservoir system

July 2018

**DAM RISK ANALYSIS FOR BHADRA DAM AND RESERVOIR  
SYSTEM  
D2.1**

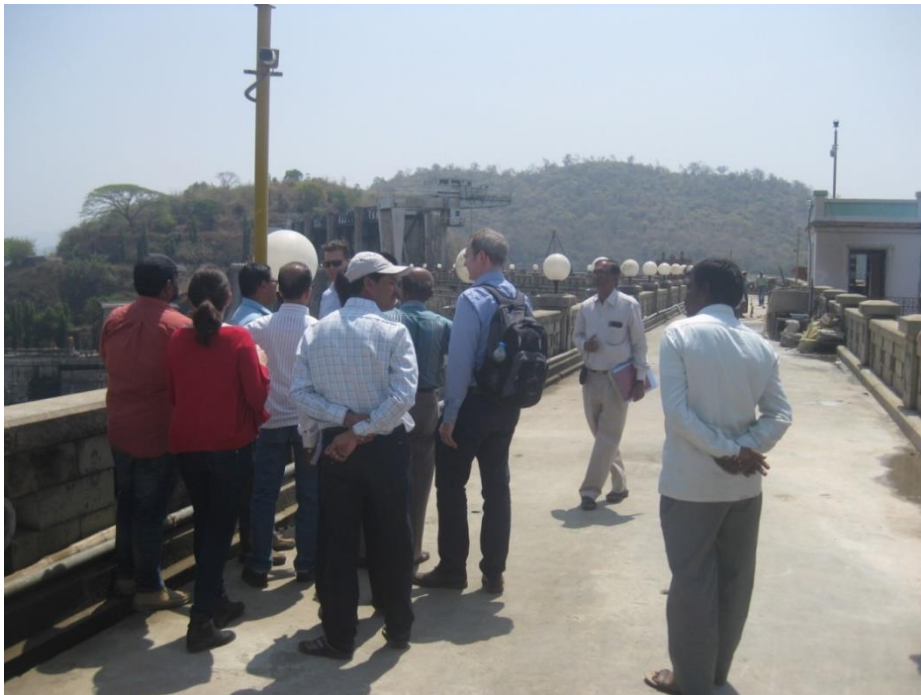
Figure 4.3. Technical site visit of Bhadra Dam. 21 February 2017.

Special attention was paid to the main problems identified during the review of information of Bhadra Dam, including aspects such as the general state of dam body and equipment, seepage, leakage, settlements and maintenance of outlet works, among others.

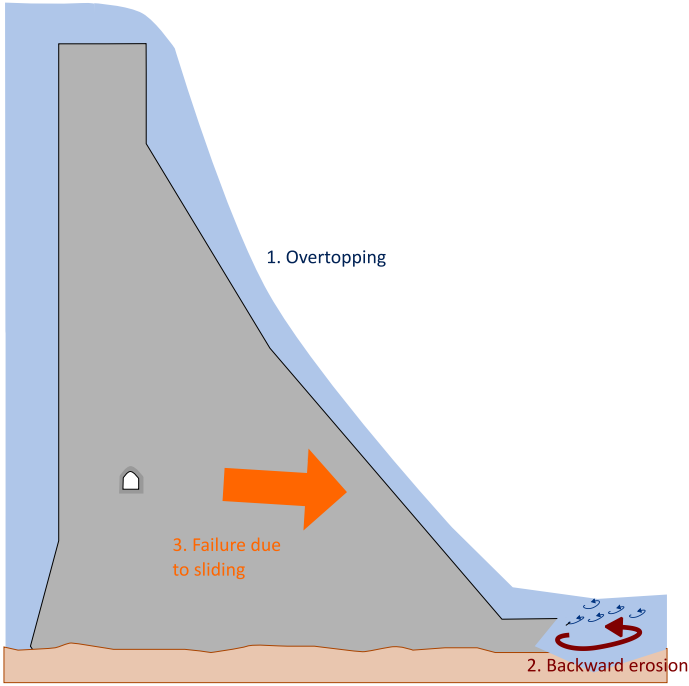
Failure Mode 1	Overtopping failure in the main dam	
Description		
<p>In a hydrologic scenario, due to a severe flood and/or inadequate spillway capacity and/or inability to open spillway gates, adequate freeboard cannot be maintained and this results in overtopping over dam crest level. Flow over the crest washes out material in the dam toe and causes massive erosion that progresses leading to the failure of the main dam.</p>		
Graphical scheme

More likely factors	Less likely factors	
<p>Lack of detailed probabilistic hydrologic studies on Bhadra Dam-reservoir upstream river basin.</p>	<p>During the monsoon season, a different maximum reservoir level is fixed at RL 2156 ft, 2 ft below MOL.</p>	
<p>Differences between original and reviewed design flood events (3,397.83 m<sup>3</sup>/s vs. 7,544 m<sup>3</sup>/s, respectively). The spillway capacity is 3,021.24 m<sup>3</sup>/s for Maximum Operating Level (MOL).</p>	<p>Spillway gates are, in general, well maintained.</p>

<p>Reservoir levels are 30% of time above RL 2154 ft. Maximum Operating Level (MOL) is established at RL 2158 ft during the dry season.</p>	<p>There are two sluices that provide additional discharge capacity up to 13,300 cusecs (376.6 m<sup>3</sup>/s).</p>	
<p>Estimated rainfall data at nearby catchments (Cauvery and West Flowing Rivers) shows precipitation rates higher than those used for past design flood analyses.</p>	<p>The stilling basin has been recently repaired.</p>

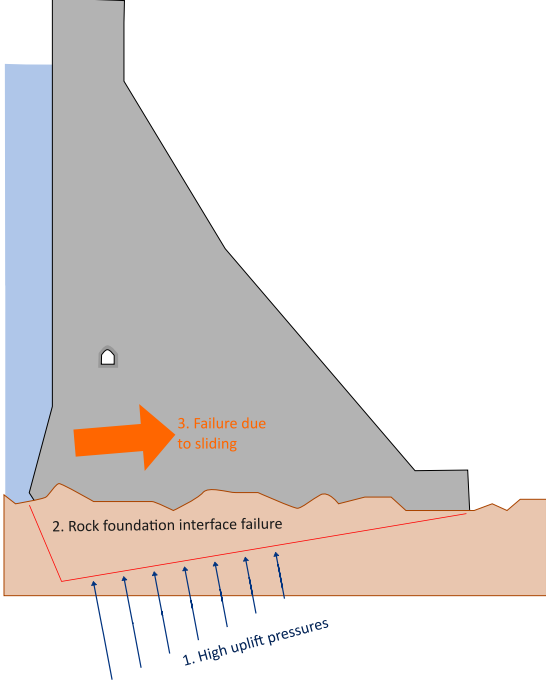
Failure Mode 3	Sliding in the main dam along a failure surface at rock foundation	
Description		
<p>In a normal or hydrologic scenario, the combination of hydrostatic loads and uplift pressures produces a movement or deformation in dam foundation over a surface, resulting in loss of foundation strength and failure due to sliding of a block or partial zone of the main dam.</p>		
Graphical scheme

More likely factors	Less likely factors	
<p>Detection of high uplift pressures is not possible (there is no instrumentation in the main dam).</p>	<p>The maximum reservoir water level specified during the monsoon season is set 2 ft below MOL.</p>	
<p>Detection of movements, as an indicator of an initiating failure mode, is not possible (there is no instrumentation in the main dam).</p>	<p>In the dam life, signs of foundations instabilities or sliding failures have not been observed.</p>	
<p>There is no detailed information on material properties at dam foundation (dam subsoil conditions are unknown).</p>	<p>Available data on the foundation indicates that this failure mode is hardly viable.</p>

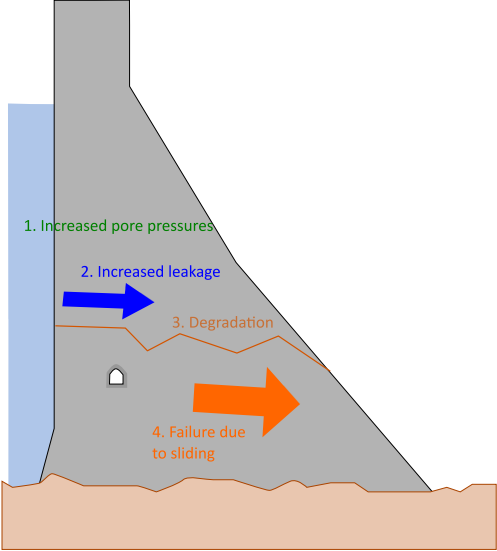
Failure Mode 5	Sliding in the main dam due to degradation of masonry material	
<b>Description</b>		
<p>In a normal, seismic or hydrologic scenario, due to a severe deterioration at the main dam, a horizontal crack initiates and evolves leading to large instability and dam breach that requires partial or total reparation, with a complete degradation of the dam toe due to water release.</p>		
<b>Graphical scheme</b>

<b>More likely factors</b>	<b>Less likely factors</b>	
<p>There is no detailed information on dam body material properties.</p>	<p>The maximum reservoir water level specified during the monsoon season is set 2 ft below MOL.</p>	
<p>There are evidences of seepage and leakage through dam body. Excessive leakage is a sign that excessive stress is occurring.</p>	<p>Despite observed leakage, there is no evidence of an initiating failure mechanism or movements that might indicate material degradation.</p>

<p>Detection of movements, as an indicator of an initiating failure mode, is not possible (there is no instrumentation in the main dam).</p>	<p>Cleaning actions for drains have been conducted to avoid clogging.</p>	
<p>There is no available information on pore pressures (there is no instrumentation in the main dam).</p>		
<p>No information or testing of dam body material strength or durability.</p>

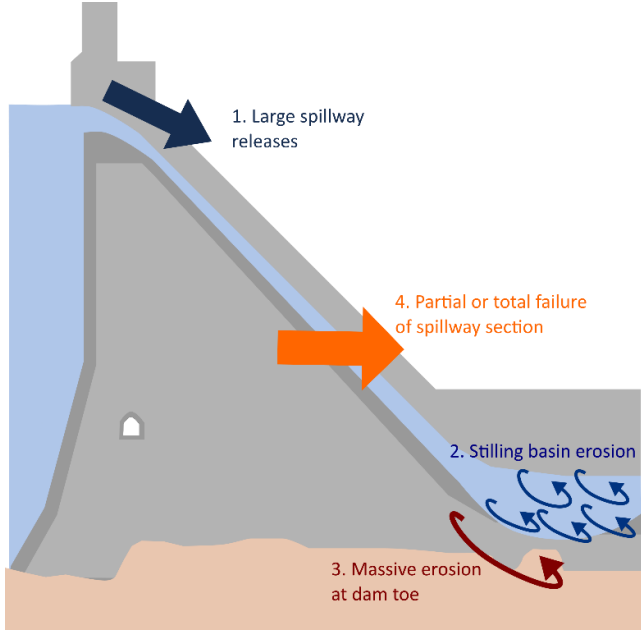
Failure Mode 10	Stilling basin failure in the main dam	
Description		
<p>In a hydrologic scenario, large releases through the spillway result in erosion of the stilling basin, then erosion at the dam toe initiates and progress backwards until the corresponding partial or total failure at the spillway section of the main dam occurs.</p>		
Graphical scheme

More likely factors	Less likely factors	
<p>Previous evidences of stilling basin erosion and deterioration of the structure.</p>	<p>The stilling basin has been recently repaired.</p>	
<p>Additional foundation erosion in the stilling basin can be caused by reservoir seepage, flowing groundwater, or seepage from local precipitation and cannot be monitored.</p>	<p>Site inspection is performed frequently to review stilling basin performance.</p>	
<p>There is no drainage system in the stilling basin.</p>		
<p>No available flood routing studies neither structural analyses that determine if the structure can withstand flood loading conditions and potential high uplift pressures in the stilling basin.</p>
