# FAME Fieldwork report

Anne Kruijt, intern at Deltares and master student Utrecht University

This report provides an overview of a three-month field campaign to the Mekong Delta of Vietnam, as part of the Deltares project 'FAME' (Freshwater availability in the Mekong Delta). The aim of the report is to provide a description of the visited field sites and activities performed at each site, discuss the first data obtained in the field and make suggestions for further research. We hope that this report will provide the necessary information for other researchers to continue work at these sites within the FAME project.

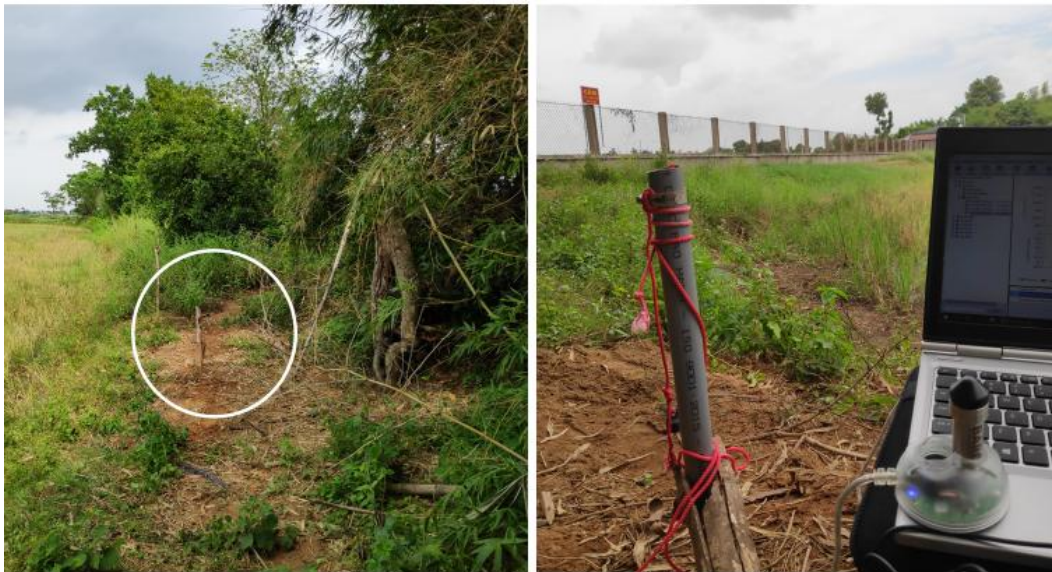
### Well1\_TV02:

The diver was installed on the 3<sup>rd</sup> of October, in a self-made observation well. This well is located opposite the AMD reservoir next to a field and a small path. It is close to the house of the farmer who is our main contact at this site, Mr. Hung. We chose this spot because it wasn't on farmland and

hence would not be in the way of farmers working on their land. We expect this well to be on the side of one of the sand dune ridges in this area. The screen of the well consists of 50 cm of small holes at the end of the tube.

*Well1, hidden from sight by some old pieces of bamboo*

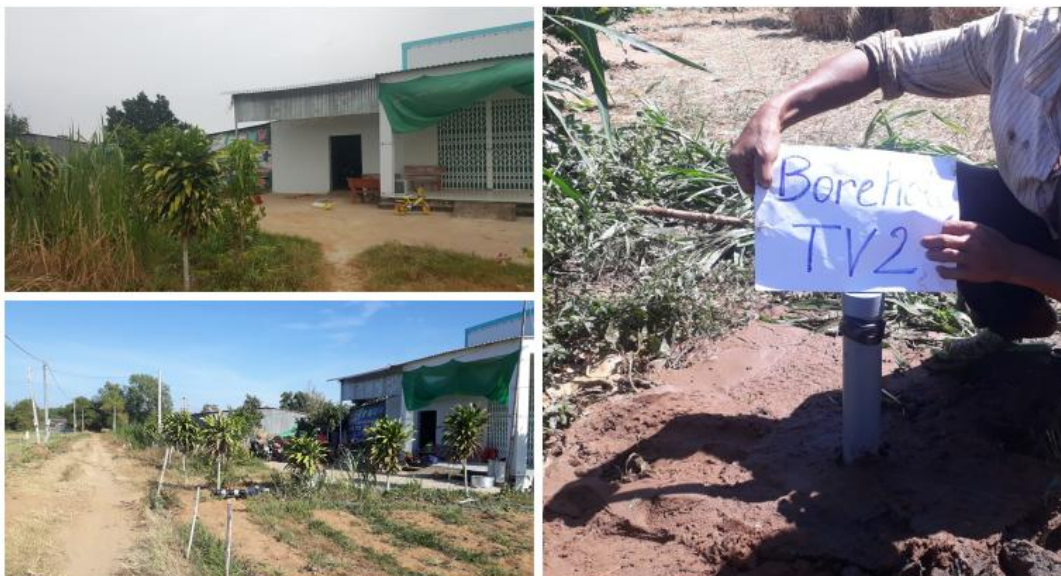
#### Well2\_D\_TV02:

The installation of this well and diver was performed on the 16<sup>th</sup> of December. A detailed well schematic with descriptions of encountered lithologies can be found in appendix 4. We expect this location to be on top of the most eastern ridge of this sand dune complex. The well is located in the front garden of the farmer Mr. Nanh, next to the small path crossing the dune. The installation took place after our last field week, so we have not yet been able to inspect the data from the diver in this well.

*Well2\_D, installed in the front garden of the house on the left upper and lower photos*

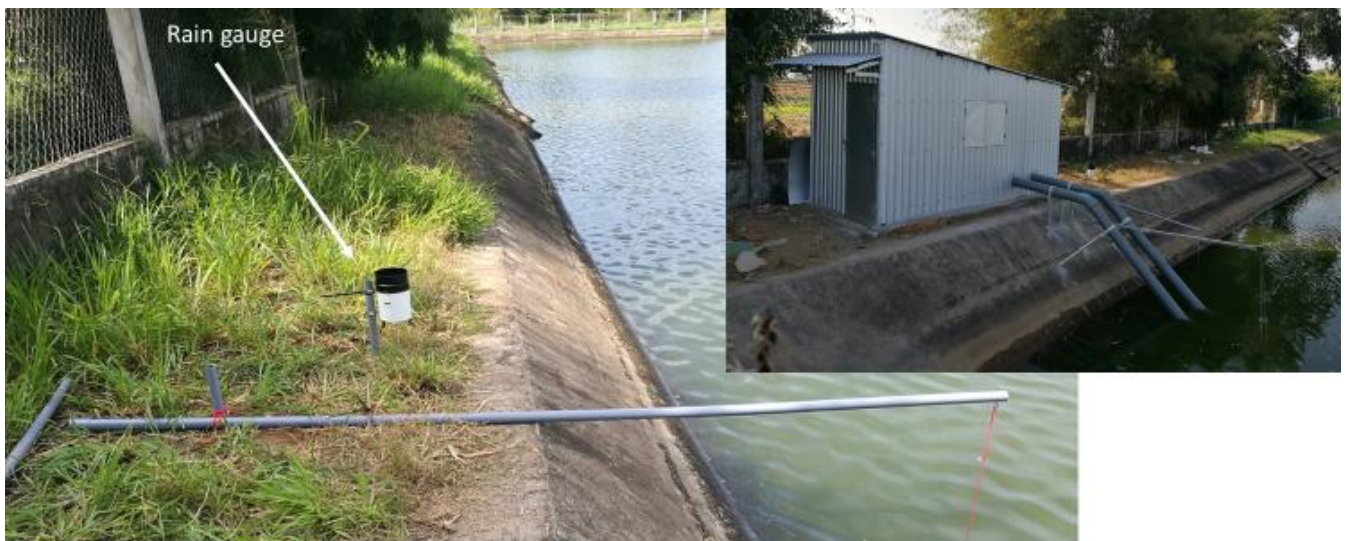
The rain gauge has been installed on the 3<sup>rd</sup> of October. From October to the end of November the rain gauge has been measuring at an interval of 1 minute, but to save memory space in the months that no researchers will be available to download data, the measuring interval has been set to once every 5 minutes. Important to note is that the pumping station extracting water from the reservoir has been installed by the AMD right next to our rain gauge. We hope this installation will not influence the amount of rain fall registered by the rain gauge.

*Rain gauge and surface water monitoring installation shown on the left. The photo on the right shows the pumping installation.*

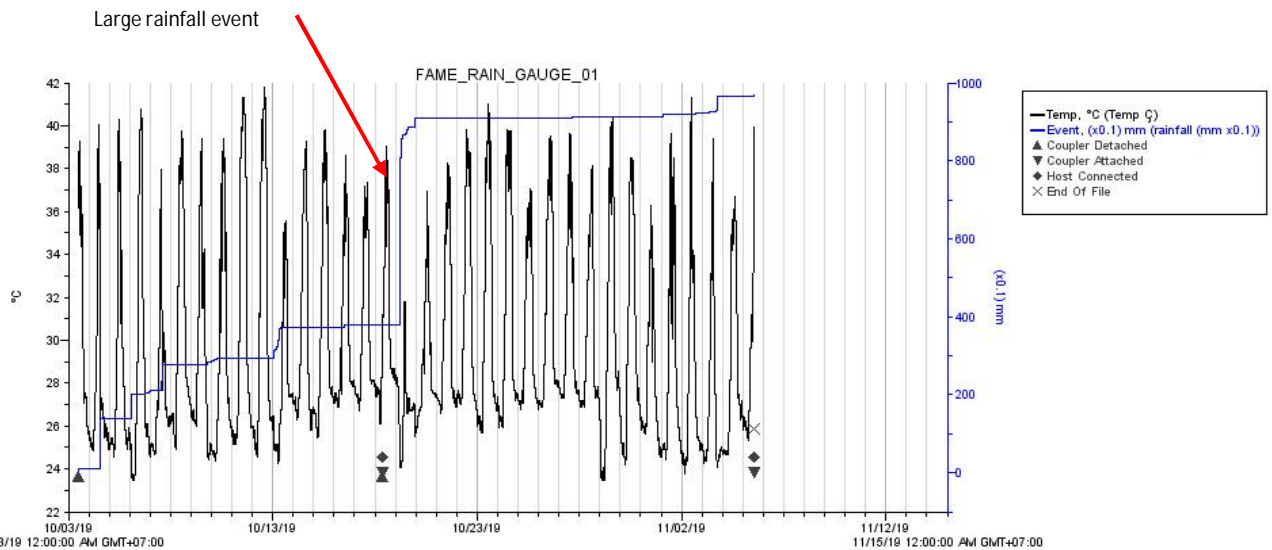
The graphs below show the cumulative rainfall for the months October to end of November and end of November to middle of December. Between the 3<sup>rd</sup> of October and the 5<sup>th</sup> of November, we can observe several small rainfall events and one larger event on the 19<sup>th</sup> of October. The rain gauge recorded a cumulative rainfall of 100 mm for the month of October, 50mm of which fell on the 19<sup>th</sup> of October. The rest of October, November and the start of December are much dryer; the rain gauge recorded a cumulative rainfall of 30 mm for this latter period.

Data as presented by the HOBO-software that comes with the rain gauge. Graph above shows the cumulative rainfall from the 3<sup>rd</sup> of October to the 5<sup>th</sup> of November. Graph below shows the cumulative rainfall from the 5<sup>th</sup> of November to the 11<sup>th</sup> of December.

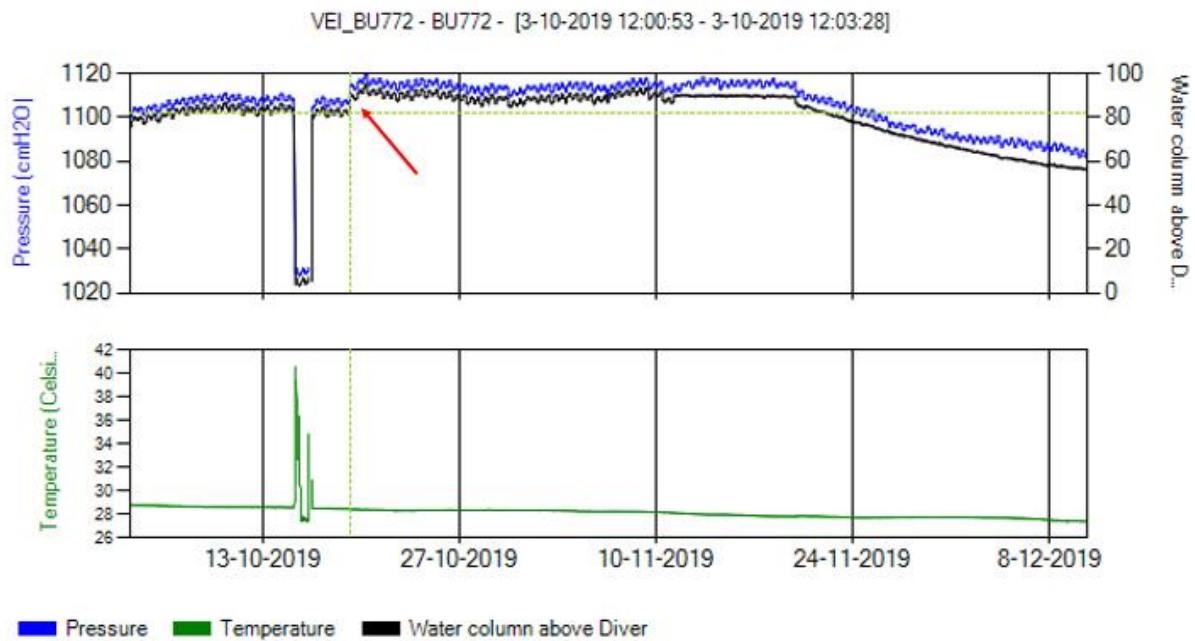
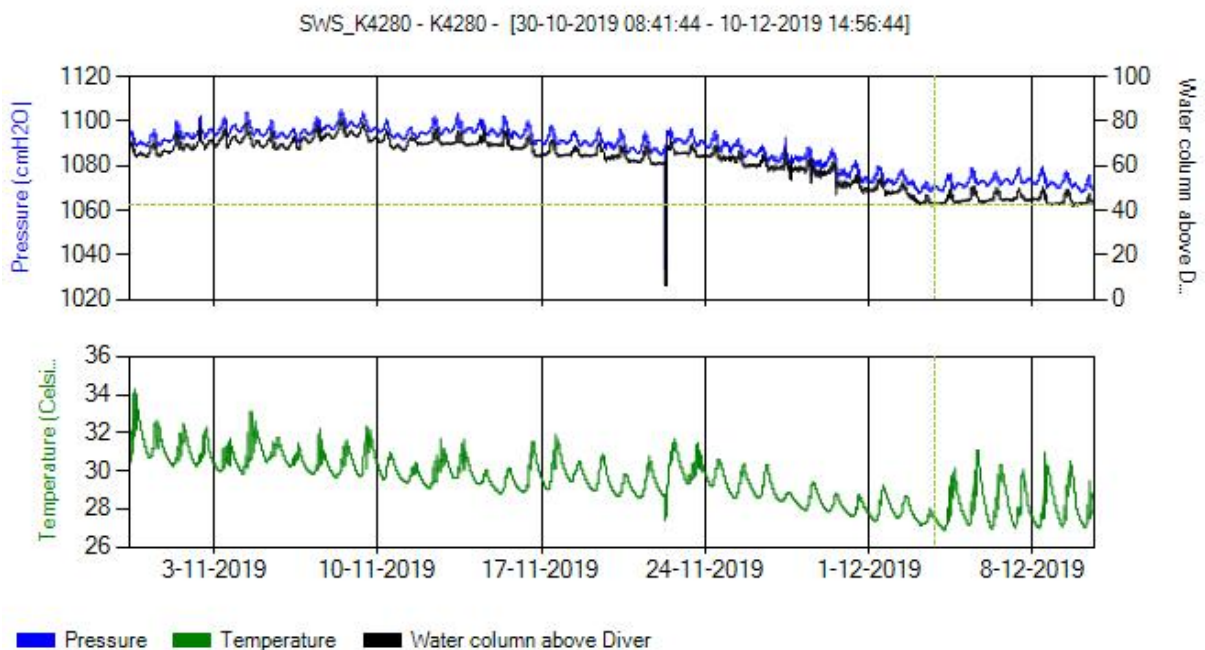
Measurements from the longest running diver at this site, located in Well1, are shown in the first graph below. We can observe a slight rise in groundwater level from the 3<sup>rd</sup> to 19<sup>th</sup> of October, with a short interruption between the 15<sup>th</sup> and 16<sup>th</sup> of October when the well was accidentally de-installed by the farmer Mr. Hung. There is a sudden rise on the 19<sup>th</sup> of October (indicated by the red arrow), and a steady decline from the 20<sup>th</sup> of November onward. In total there has been a drop of 27 cm in groundwater level over the months October to December. Since the rain gauge registered quite some rain fall in October and an especially large amount on the 19<sup>th</sup> of this month, this might explain the slight rise we observe during this period and the sudden rise in ground water level on the 19<sup>th</sup>.

Data from the diver as presented in the Diver-office software. The diver measures pressure and temperature of the water and the software can then calculate the water column above the diver, by compensating for atmospheric pressure. A barometer diver is installed at another field site (BT02) and the data used to compensate measurements at all field sites. The barometer was installed permanently on the 11<sup>th</sup> of November, meaning that for the first month only some single measurements of atmospheric pressure are available and compensation is not done correctly.

The second graph shows the surface water level in the AMD reservoir between the 30<sup>th</sup> of October and 10<sup>th</sup> of December. A steady drop in water level is observable between the 22<sup>nd</sup> of November and the 3<sup>rd</sup> of December, after which the water level seems to stabilize again. This drop, of approximately 26 cm, is similar in timing and magnitude to the drop observable in the groundwater, indicating that these two systems are indeed connected. The large sudden drop in the surface water level on the morning of the 22<sup>nd</sup> of November is caused by the piezometer briefly being taken out of the water, possibly due to construction works related to the installation of the pumping station. The

steady decline in groundwater and surface water levels from the 20<sup>th</sup> of November onwards is possibly related to the onset of controlled extraction from the AMD reservoir. However, since we do not know when the controlled extraction from the AMD reservoir started exactly and how much water is extracted per day on average, it is hard to be certain about this.

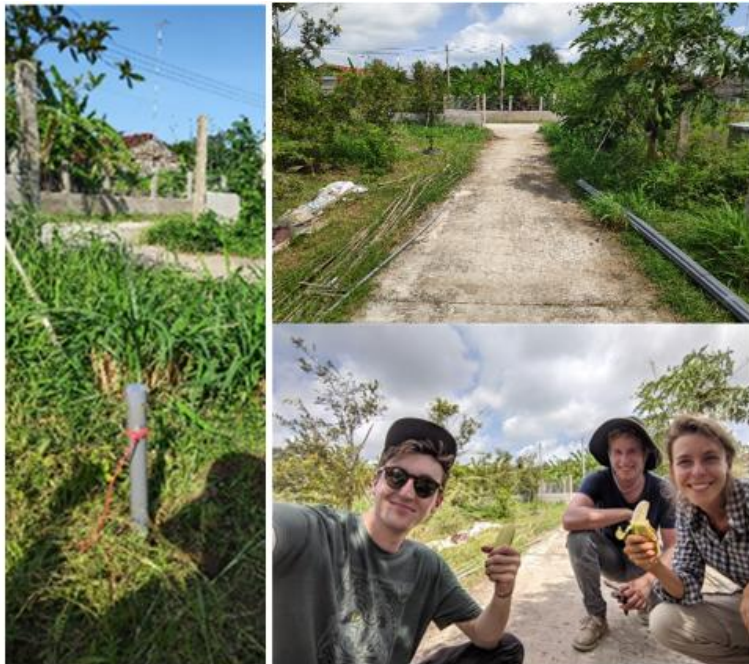
### *Well1\_BT02:*

The diver was installed on the 23<sup>rd</sup> of October, in a self-made observation well on the property of a farmer living off the main road (Mr. Phuoc). We chose this location because it seems to be slightly higher elevated (not in a rice field) and expect it to be part of the sand dune. Also, here it is under the protection of the farmer, and separated from the main road by a fence. The Baro-diver is also installed in this well, hanging just below the cap. It was placed in the well on the 11<sup>th</sup> of November. The screen of this well consists of 50 cm of small holes at the end of the tube and a mesh on the inside.

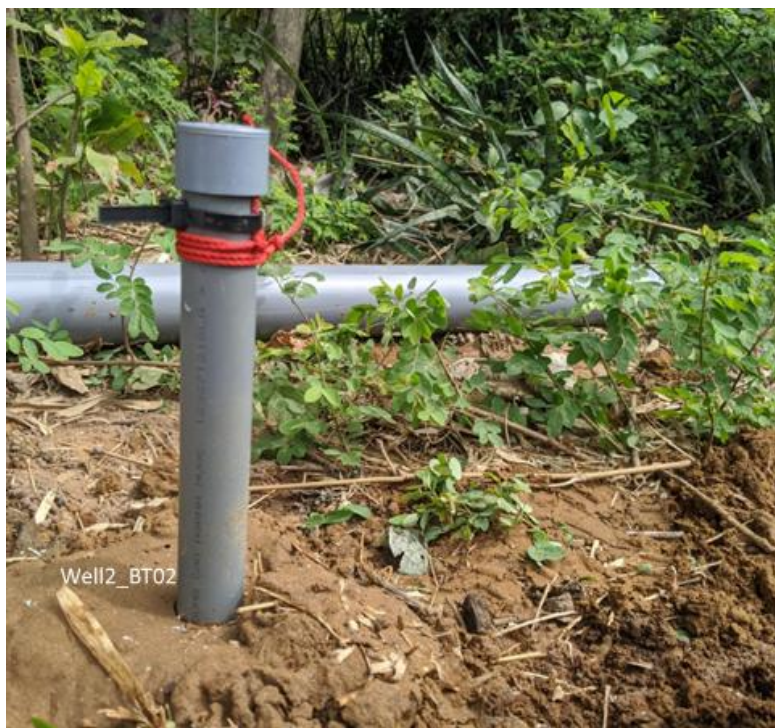
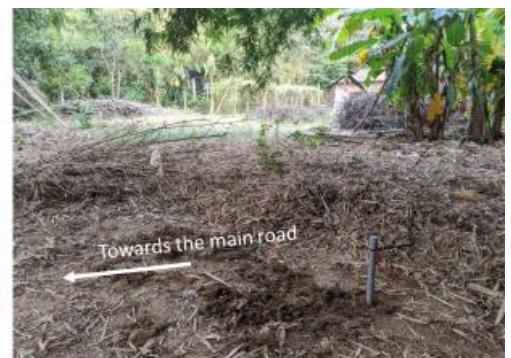
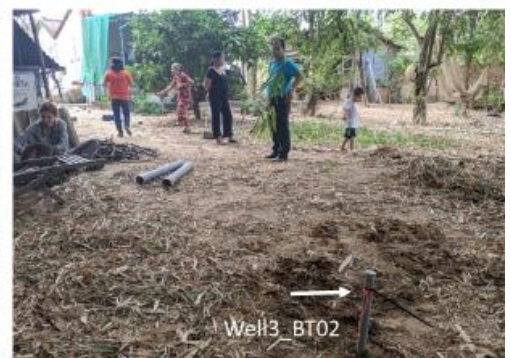
The diver was installed on the 7th of December, in a self-made observation well on the property of Mr. Phuoc. This farmer owns a lot of land in this village (Well1 is located in his garden). This site is located directly next to the road and expected to be near- top of sand dune. The well is protected from sight by some bushes and situated next to a house of a farmer who will keep an eye on the well. The screen of this well consists of 60 cm of small holes on the bottom of the tube without an additional mesh on the inside, as the holes of the mesh were almost the same size as the holes in the tube, and the mesh was hampering proper attachment of the screen to rest of the tube. The installation of the well was a bit troublesome. Due to collapsing of the hole and the very fine sand present at depth, we could only get the tube down to about 3.5m below ground surface. When placing the diver it hit a sandy layer *inside* the tube, meaning fine sand must have passed through the holes of the mesh when we pushed the pipe into the ground. We had to place the diver above this sandy layer for it to hang freely in the water column. We hope it is placed deep enough to be below the permanent water table and that the pipe will not become clogged further.

The diver was installed on the 7th of December, in a self-made observation well on the property of Mrs Xeo. Her house is next to the main road, and the well is located behind the house, next to some large bamboo trees. We expect this location to be on the eastern side of the sand dune. The screen consists of 60 cm of small holes at the end of the tube, with no additional mesh inserted on the inside. Our concerns for this well are the same as for Well2; we experienced fast collapse of the hole while installing the tube, and there was some fine sand on the inside of the tube when we placed our diver.

*Well2 (left) and Well3(right)*

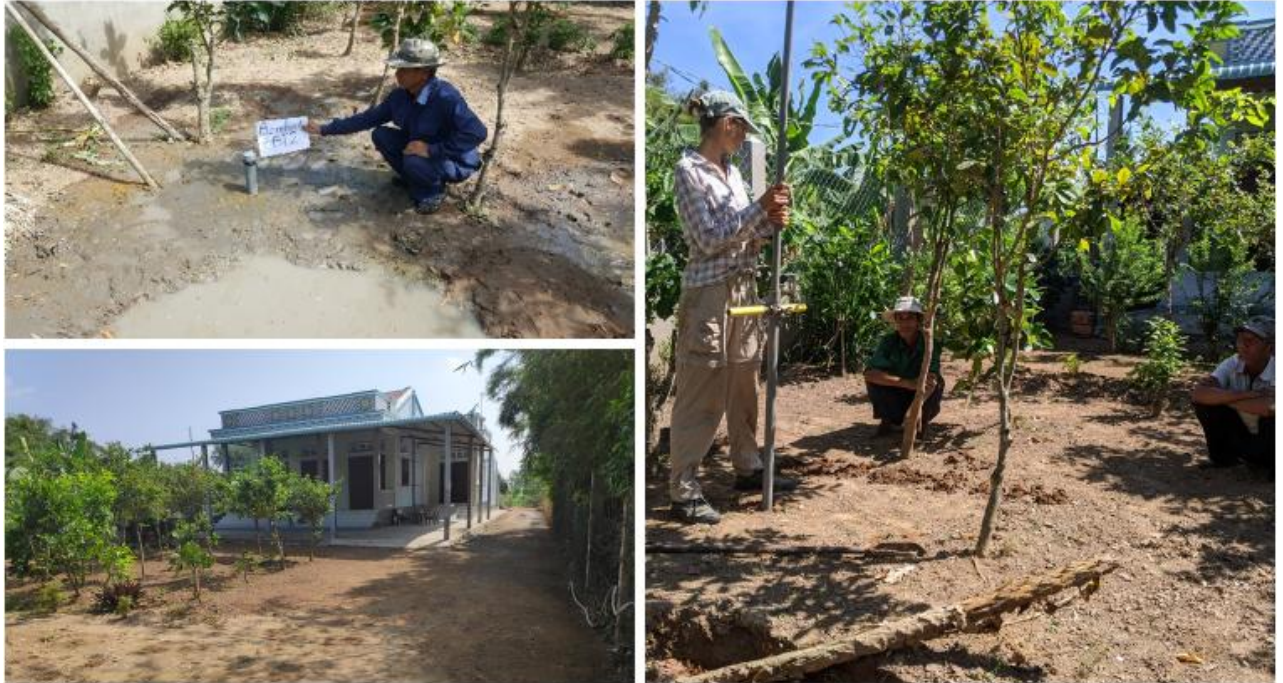
#### *Well4\_D\_BT02:*

The installation of this well and diver was performed on the 15<sup>th</sup> of December. A detailed well schematic with descriptions of encountered lithologies can be found in appendix 4. A small clay layer was encountered at approx. 10m depth and it was decided by the drilling team to place the screen

below this clay layer, from 11.5 to 12.5m. We are not sure if this thin clay layer is continuous and thick enough to create a confined aquifer below, or if in fact the sand in which the screen is placed is part of the unconfined aquifer, in which case it might have been preferable to have a larger screen also connected to the sand above the clay layer. Since the installation took place after our last field week, we have not yet been able to inspect the data from the diver in this well.

*Well4\_D, located in the front garden of Mr. Lua*

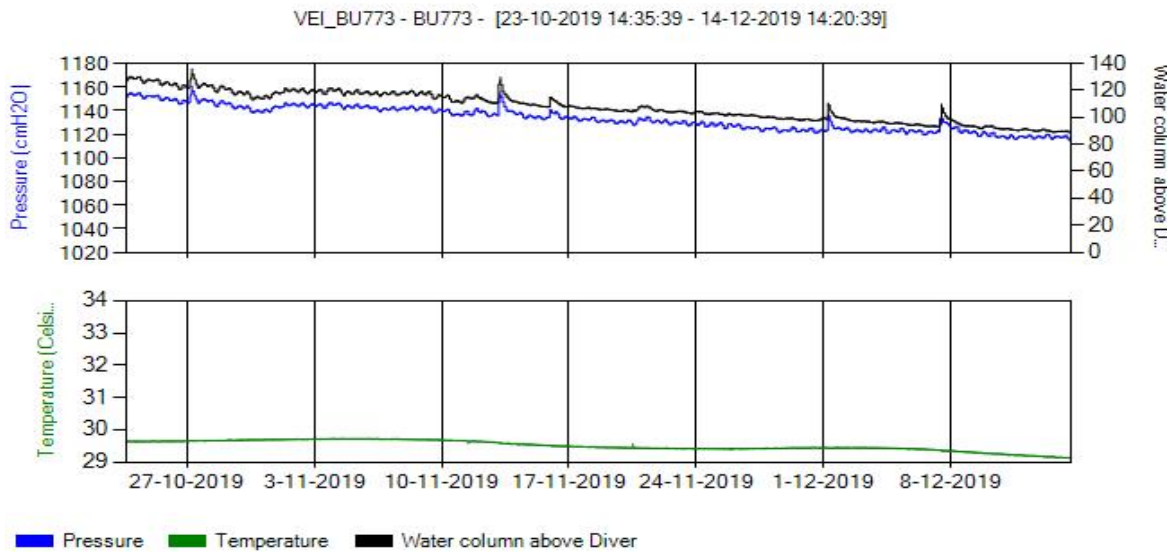
Measurements from the longest running diver at this site, located in Well1, are shown in the graph below. We can observe a steady decline in groundwater level, with some interesting spikes at: 27<sup>th</sup> of October, the 13<sup>th</sup> and 16<sup>th</sup> of November and the 1<sup>st</sup> and 7<sup>th</sup> of December. These might be due to heavy rainfall, but we have no measurements to back this up, since there is no rain gauge on site. Because rain fall in this region can be very local, data from the rain gauges at the other two sites might not be representative. Another possibility is that human activity in the garden in which this piezometer is located has caused these momentary higher water levels. From the interview with Mr. Phuoc we know that the trees and grass in this garden is watered regularly. In total the water level has dropped approximately 40 cm over the months October to December.

Well1\_BT02, diver placed 190 cm below ground surface

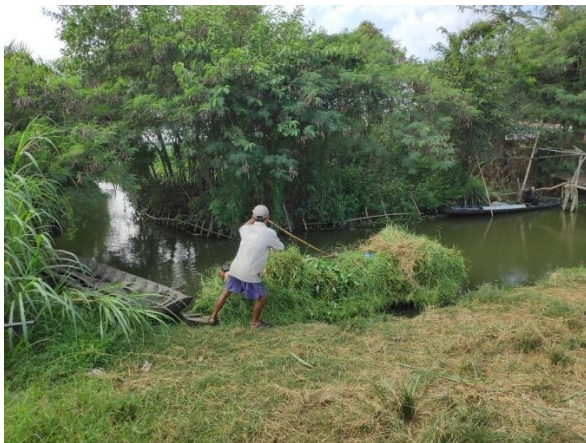
*Small system of ditches west of dune (location 1 in map 2)*

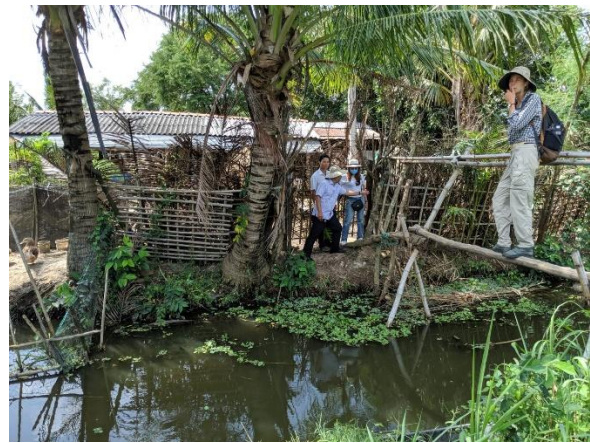
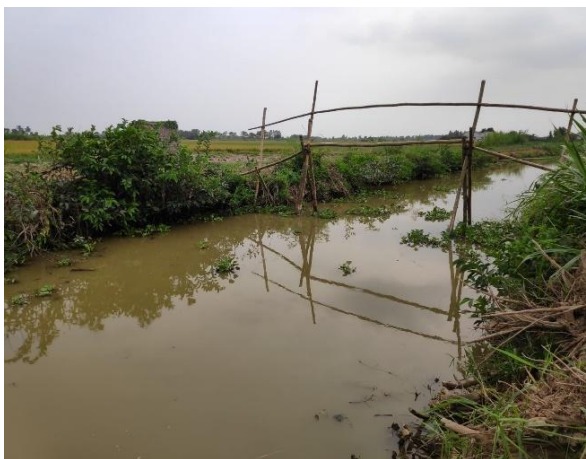
*Small canal east of dune (location 9 in map 2)*

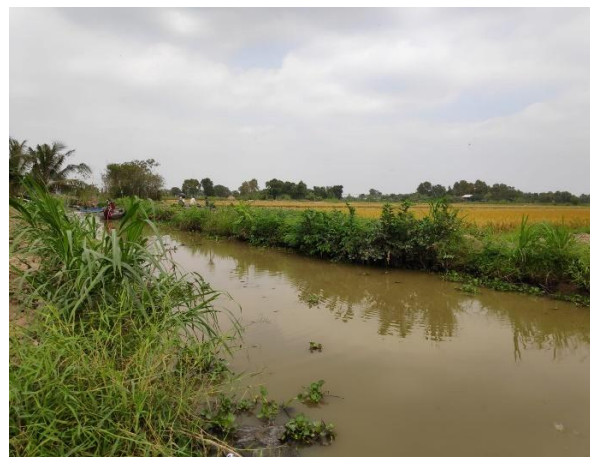
*(same canal)*

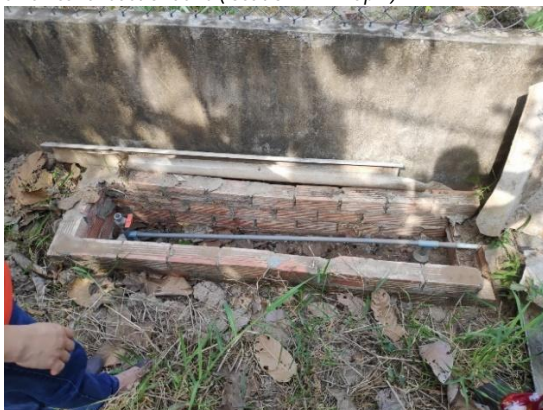
*Example of a pump well (location 15 in map 1)*

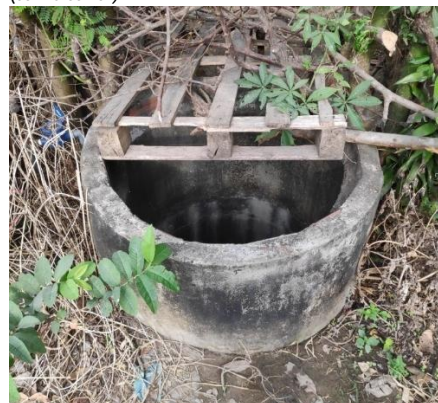
*Example of an open well (location 19, in map 1)*

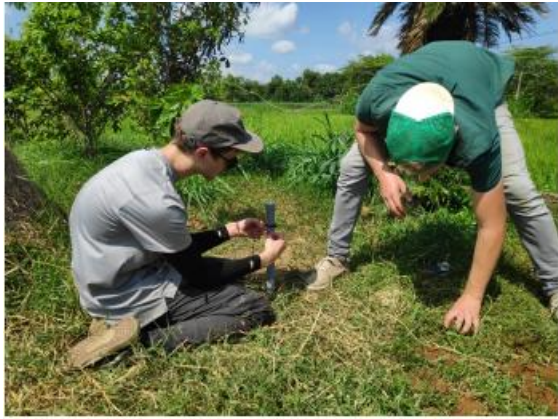
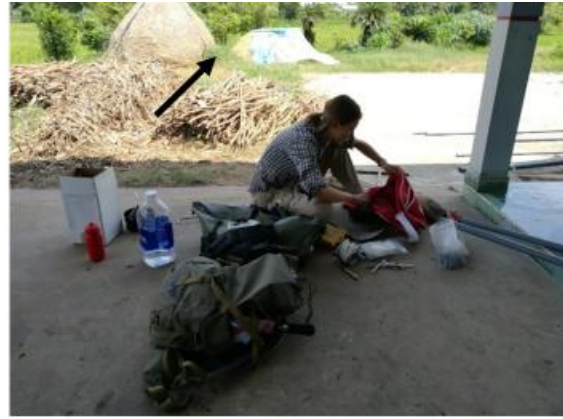
*Well1 on the property of Mr. Hieu*

A CTD-diver was installed on the 24<sup>th</sup> of October, in this self-made observation well on the property of the farmer Mr. Hieu. We chose this location because it is under the protection of the farmer, and slightly off the main road. The screen consists of 50 cm of small holes at the end of the tube and a mesh on the inside. We suspect this well to be located close to the top of the sand dune, based on the sandy subsurface present and its location on the DEM. On the 14<sup>th</sup> of December, the CTD-diver was placed in a different well (Well3\_D\_BT03) and replaced by a normal diver measuring only temperature and waterlevel.

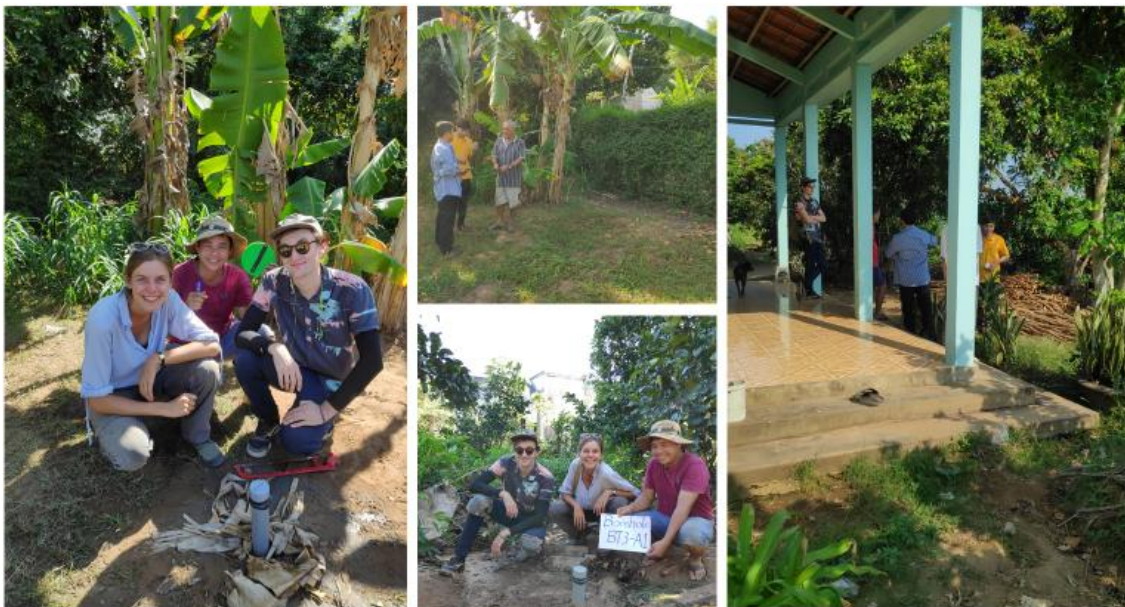
*Well2\_D (left) and landowner (upper middle) and Well3\_D (lower middle) and location of Well3\_D (right)*

The installation of this well and diver was performed on the 13<sup>th</sup> of December. This well is located on top of the sand dune in the front garden of Mr. Bay, next to a field of fruit trees. One meter of screen was placed at a depth of 7.3 to 8.3 meters and the diver hung just above the screen.

The installation of this well and the diver was performed on the 13<sup>th</sup> of December. This well is located on top of the sand dune in the back garden of Mr. Phuong, behind the house. One meter of screen was placed at a depth of 5.5 to 6.5 meters and a CTD-diver was hung just above the screen.

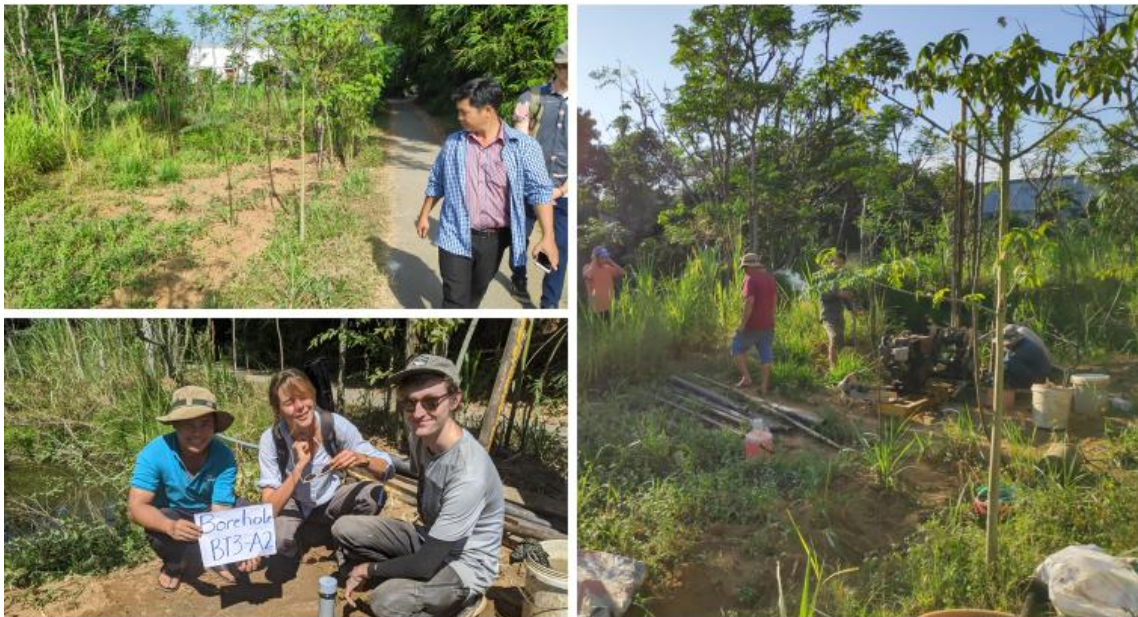
*Well4\_D, located in a small field next to a water hole and a road.*

The installation of this well and diver was performed on the 14<sup>th</sup> of December. We expect this location to be more towards the side of the sand dune. It is located next to a junction between two small roads and quite close to a water hole, in a small grass field belonging to Mr. Tha. A layer of sandy clay was encountered from 5.7 to 6.8 m and it was decided by the drilling team to interpret this as an aquitard layer and place a small screen of 40 cm in the sand below this layer, interpreted as a confined layer. We are not sure if this interpretation is correct and the clay encountered above this sand is indeed creating a confined layer, or if in fact the sand in which the screen is placed is part of the unconfined aquifer, in which case it might have been preferable to have a larger screen also

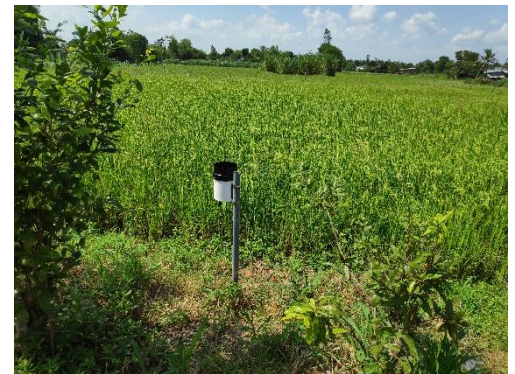
The rain gauge has been installed on the 24<sup>th</sup> of October, on the property of Mr. Hieu. From October to the end of November the rain gauge has been measuring at an interval of 1 minute, but to save memory space in the months that no researchers will be available to download data, the measuring interval has been set to once every 5 minutes.

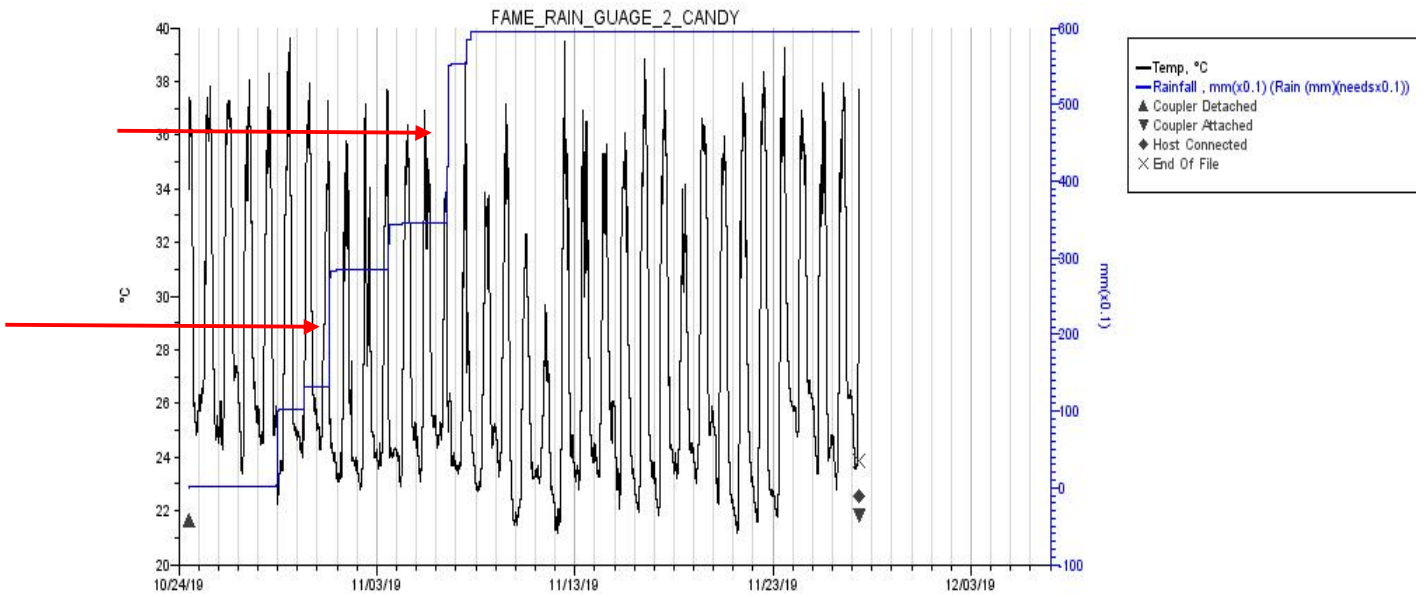
Cumulative rainfall for the 24<sup>th</sup> of October to the 27<sup>th</sup> of November. Red arrows indicate the above-mentioned large rainfall events.

The graph below shows the cumulative rainfall for the months October to end of November and end of November to middle of December. Between the 24<sup>th</sup> of October and the 8<sup>th</sup> of November, we can observe approximately six rainfall events, the largest on the 31<sup>st</sup> of October (15mm in one day) and the 6<sup>th</sup> of November (20mm in one day), and a cumulative rainfall of 60 mm for this period. The rest of November and the start of December is much dryer. The rain gauge recorded a cumulative rainfall of 12 mm for this latter period, but since the 'rainfall' events coincide with coupling and decoupling of the logger, we expect these measurements to be incorrect, caused by the accidental tipping of the measuring cup while handling the logger and the graph is not shown here.

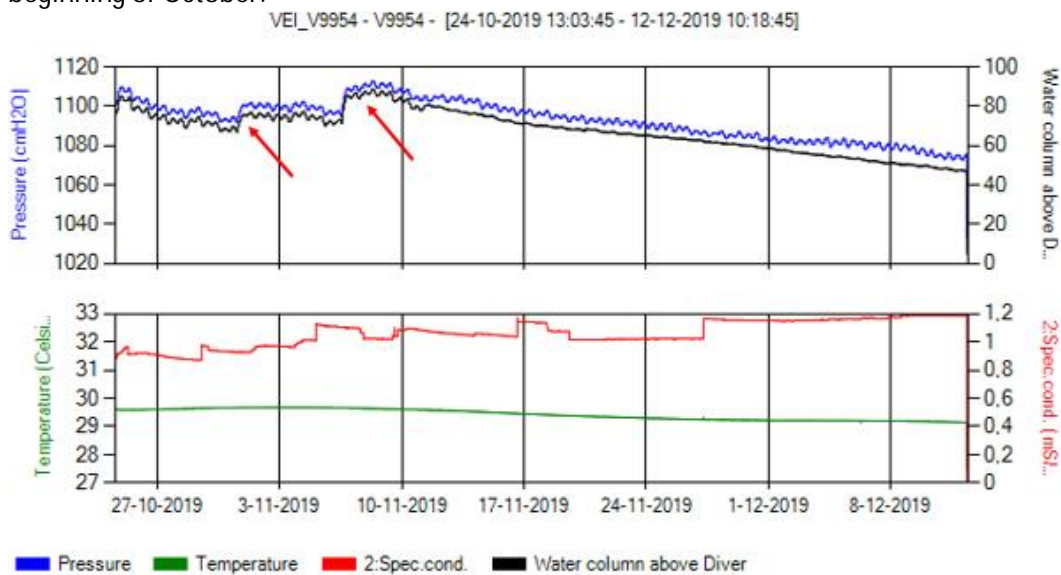
Groundwater level (top) and salinity (bottom) in well1, red arrows indicating timings of two large rain fall events

Measurements from the longest running diver at this site, located in well1, are shown in the graph below. We can observe a decline in groundwater level from the 24<sup>th</sup> of October to the 6<sup>th</sup> of November, interrupted by a sudden rise on the 31<sup>st</sup> of October, probably related to the rainfall event observable in the rain gauge data. A second large rise occurs at the 6<sup>th</sup> of November, related to another large rainfall event. After this second rise, the groundwater starts to steadily drop again from the 10<sup>th</sup> of November onwards. There has been a total drop in groundwater level of 30 cm over this entire period. The bottom graph shows the salinity of the groundwater in the well. There is a small increase in salinity over the months, from 880 to 1200  $\mu\text{S}/\text{cm}$ .

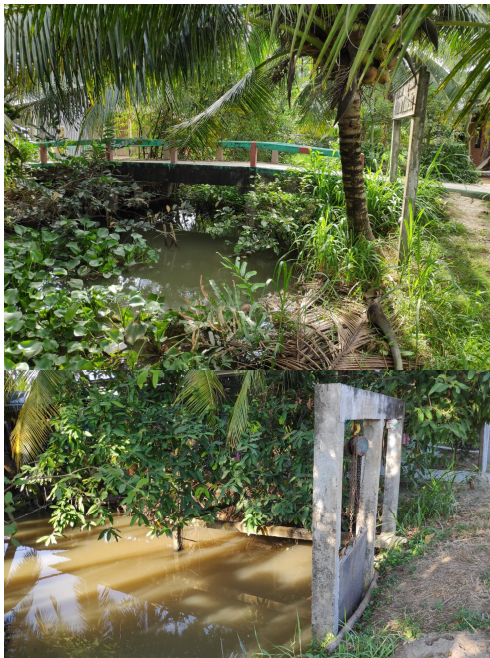
Canal to the east of the field site (locations 42 (top) and 13 (bottom) in map 2)

The measuring spots (see map 2 in appendix 5.3) were all visited once, and measurements performed in the months November and December. Measured salinity values in the ponds are highest and range between 1000 and 2000 ( $\mu\text{S}/\text{cm}$ ). These ponds are mostly located on the sides of the sand dunes. Lowest salinity values of between 300 and 600  $\mu\text{S}/\text{cm}$ , were measured in the small canal and ditches attached to the canal. This suggests that salinization is not (yet) occurring in the canals at this time of the year. To monitor the onset of salinization in the canals, a CTD-diver could be installed in the small canal, potentially at location 42 or 13 in map 2.

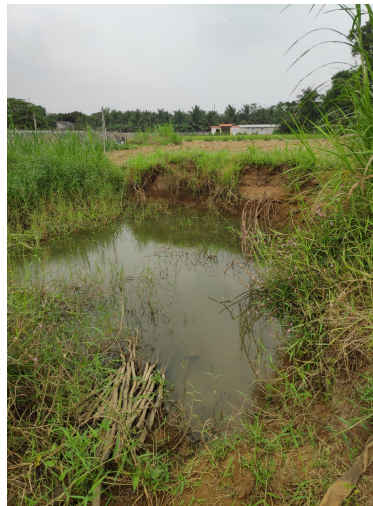
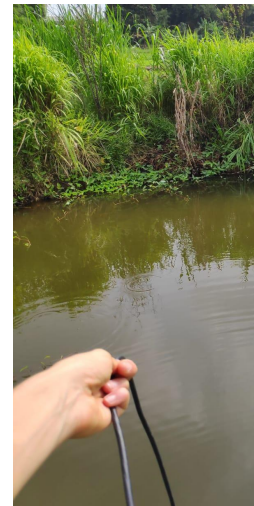
Measuring in a waterhole (e.g. locations 35, 34, 33 and 3, 4, 5 in map 2)

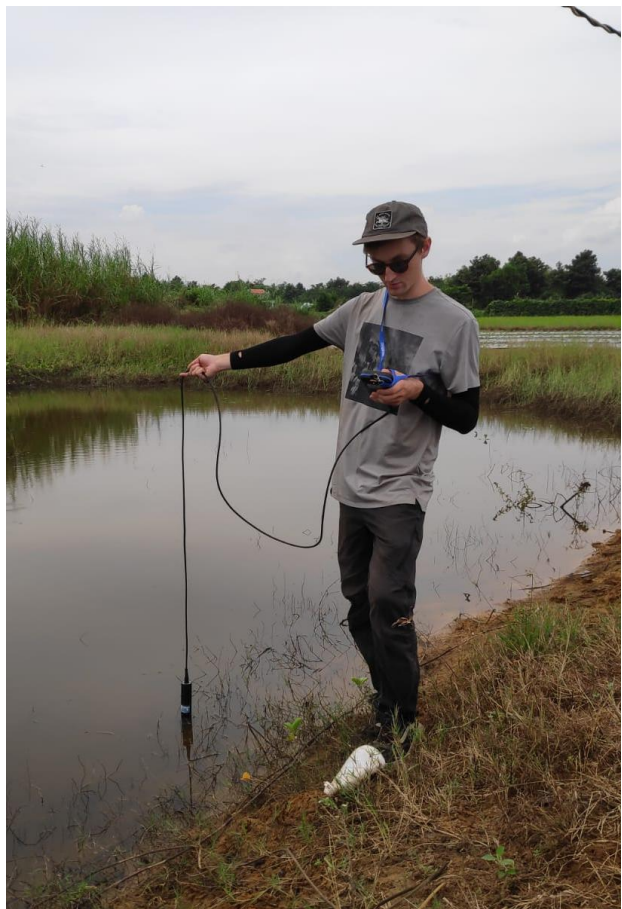
Measuring in a pond with the probe

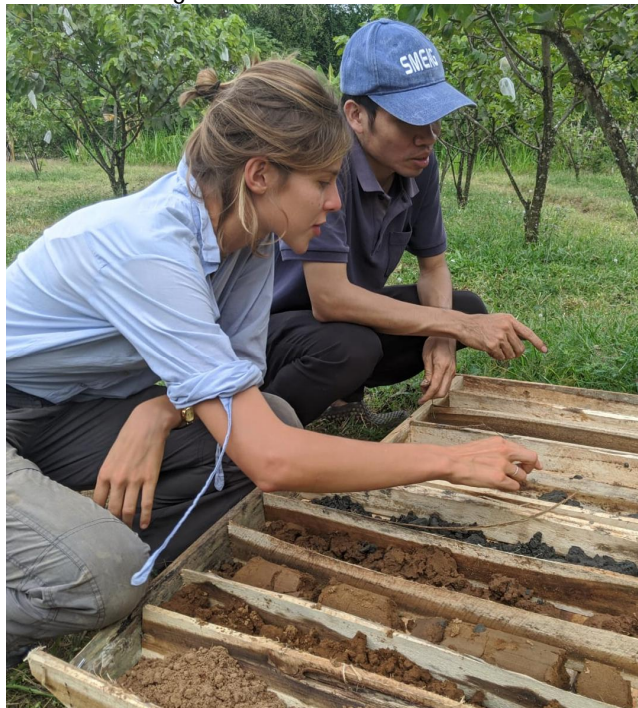
Sediment cores delivered by drilling team

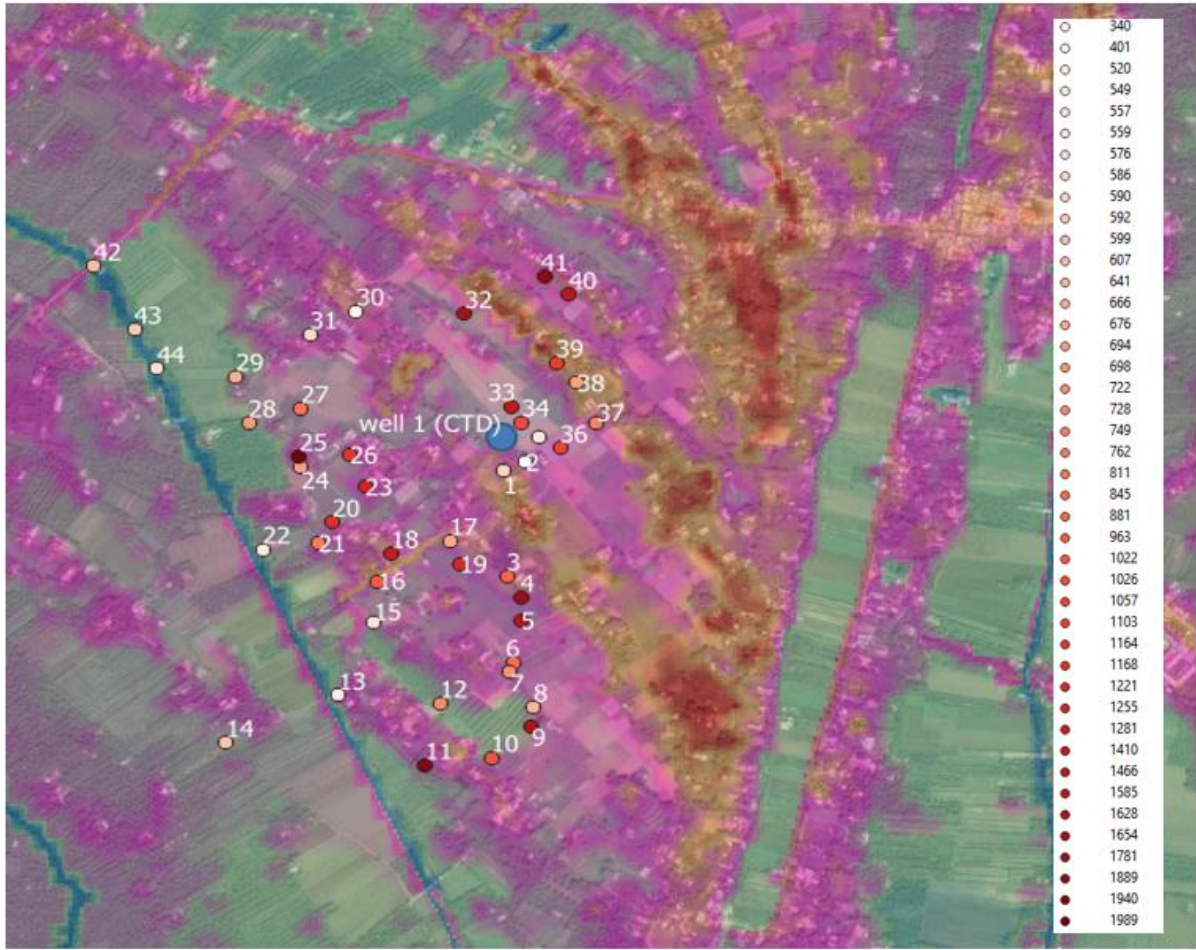
Map2: Surface water quality measurements, legend showing the measured EC values in  $\mu\text{S}/\text{cm}$
